INSPECTION REPORT

For the Property at:
69 CHICAGO AVE
COLUMBUS, OH 43222

Prepared for: MATTHEW HONDA
Inspection Date: Wednesday, February 25, 2026
Prepared by: James Jones Licensed

Report No. 12911

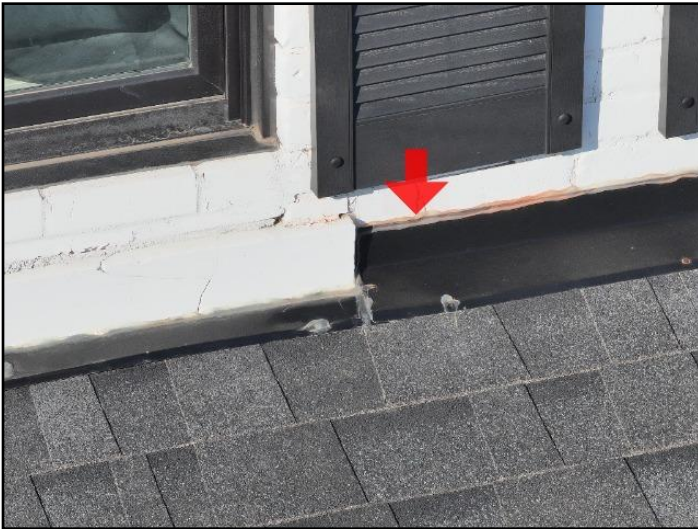
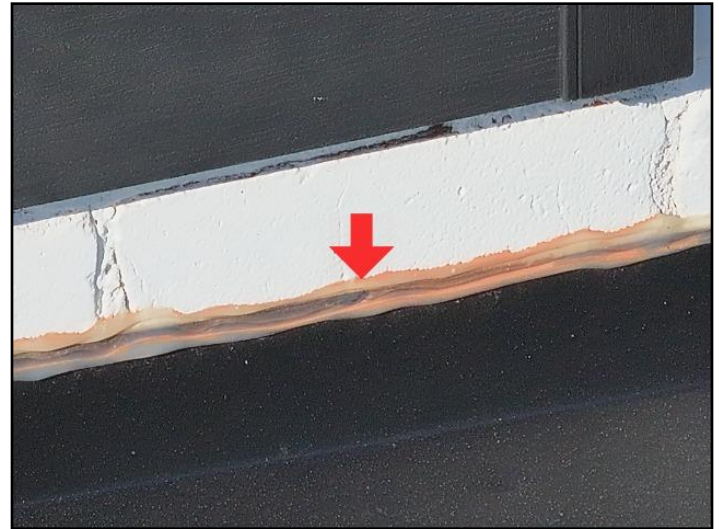
1. Condition: • [Not let into mortar joints](#)

Flashing is critical to the long-term performance of masonry and must be properly detailed to prevent moisture intrusion. Flashing that does not fully extend through the wall and out to the exterior with a proper drip edge is ineffective. It should extend into the mortar joint and be struck tight with mortar - not simply sealed with caulking.

6. Not let into mortar joints

7. Not let into mortar joints

Flashing and counterflashing must be properly lapped and continuous, with all bends and joints fully sealed. I recommend periodic monitoring and having a qualified roofing contractor repair or upgrade the flashing as needed to maintain proper water management.

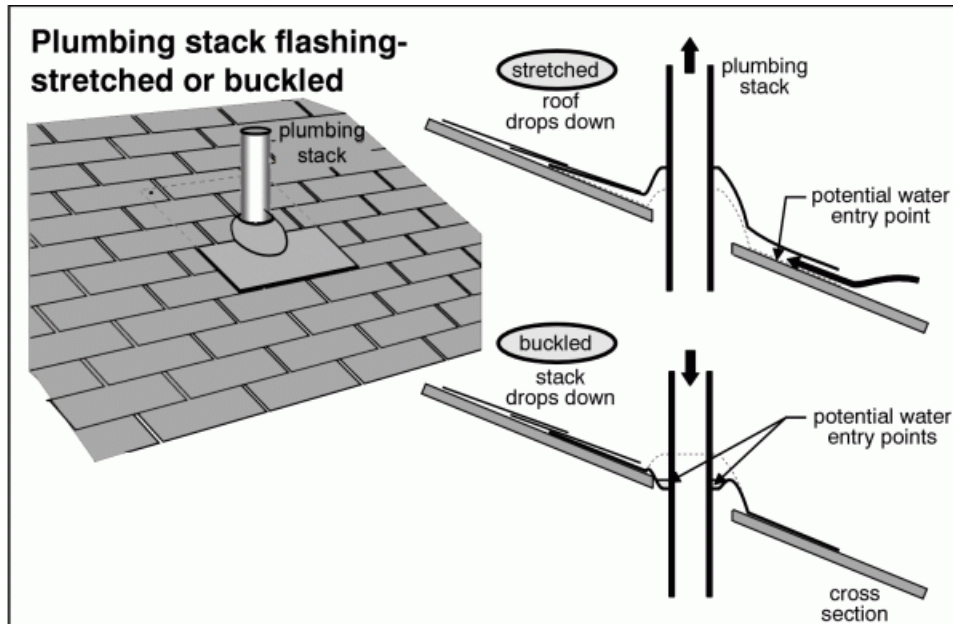
2. Condition: • The pipe boot collars exhibit signs of buckling or stretching, which is typically caused by movement of the piping that protrudes through the penetration collar. This issue may be attributed to inadequate piping support or repairs related the mechanical piping, or even storm-related factors. If the pipe boot is not properly functioning as designed to deflect water, it can lead to water pooling on the boot, which increases the risk of water intrusion. It is evident that the collars are buckled or stretched and require repair or replacement to prevent further issues.

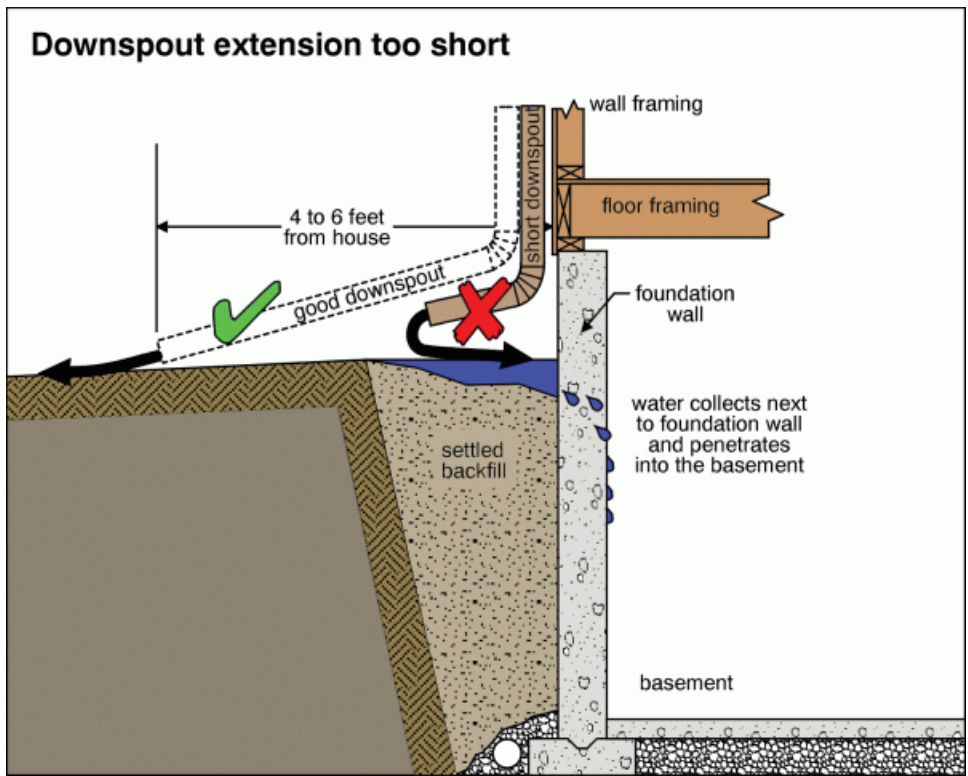
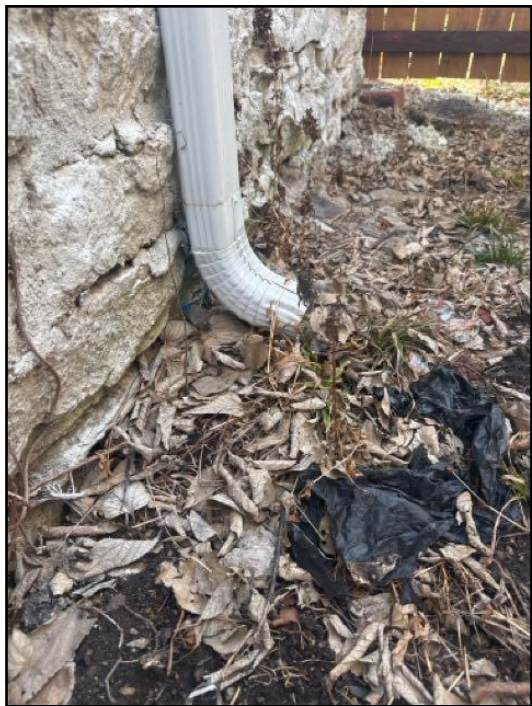
3. Condition: • [Should discharge 6 feet from building](#)

The gutters should be extended six feet beyond the foundation wall. This will prevent hydrostatic pressure from building up around the foundation wall causing the structure to fail and leak. I recommend improving this condition to prevent or stop any water damage to the building.

11. Should discharge 6 feet from building

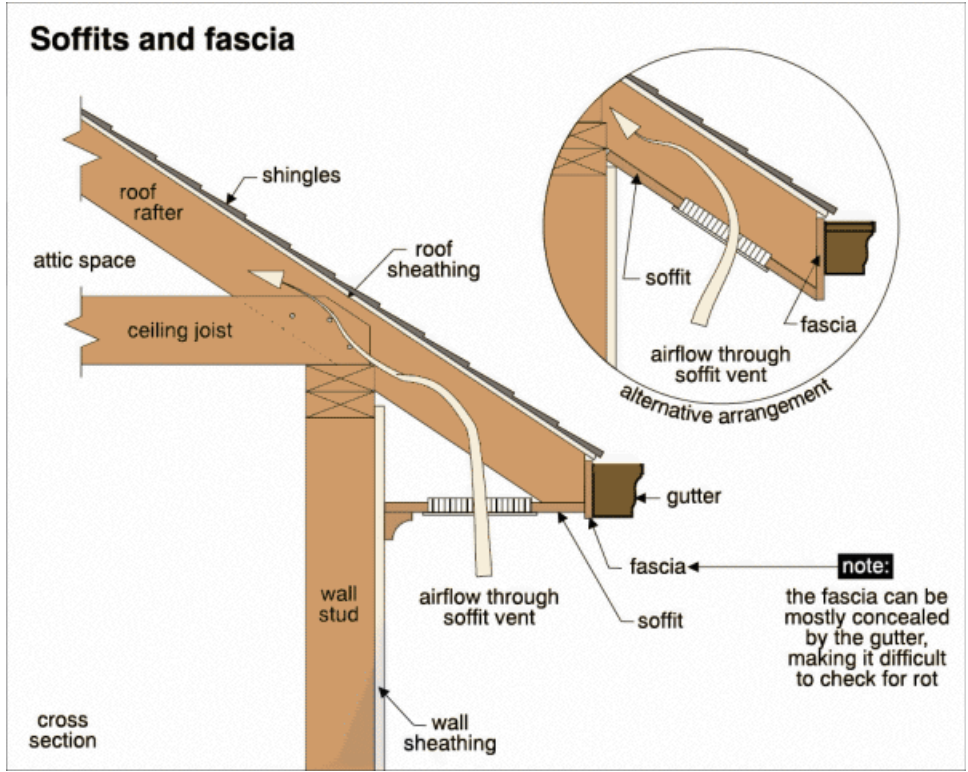
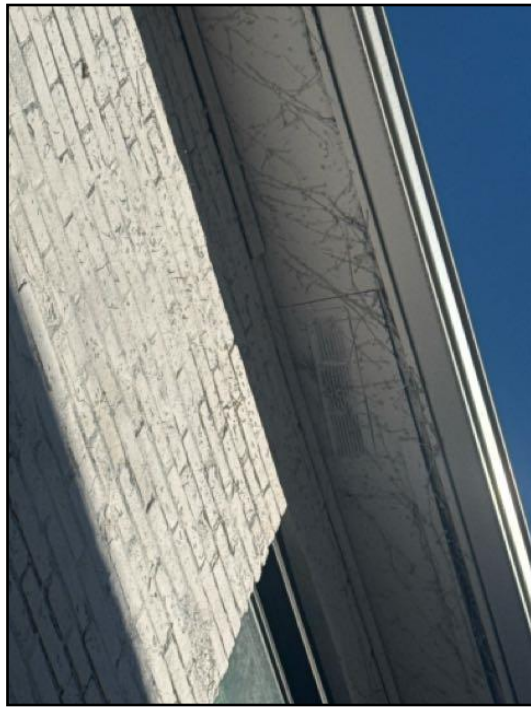
4. Condition: • [Vents - ineffective / missing](#)

and prevent mildew and rot by reducing moisture buildup. I recommend improving the soffit ventilation to extend the life of the building materials.

12. Vents - ineffective / missing

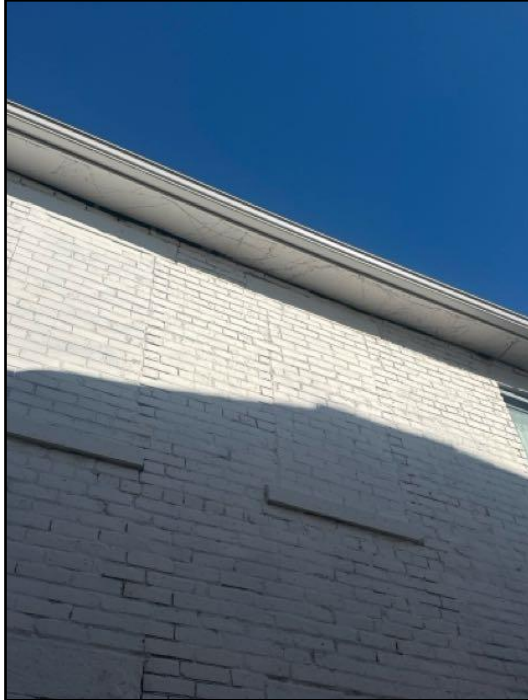
13.

5. Condition: • Open gaps were observed at the perimeter of the soffit. These openings should be sealed to help prevent pest entry into the attic. I recommend installing appropriate trim or frieze boards to close the gaps and improve the overall fit and finish.

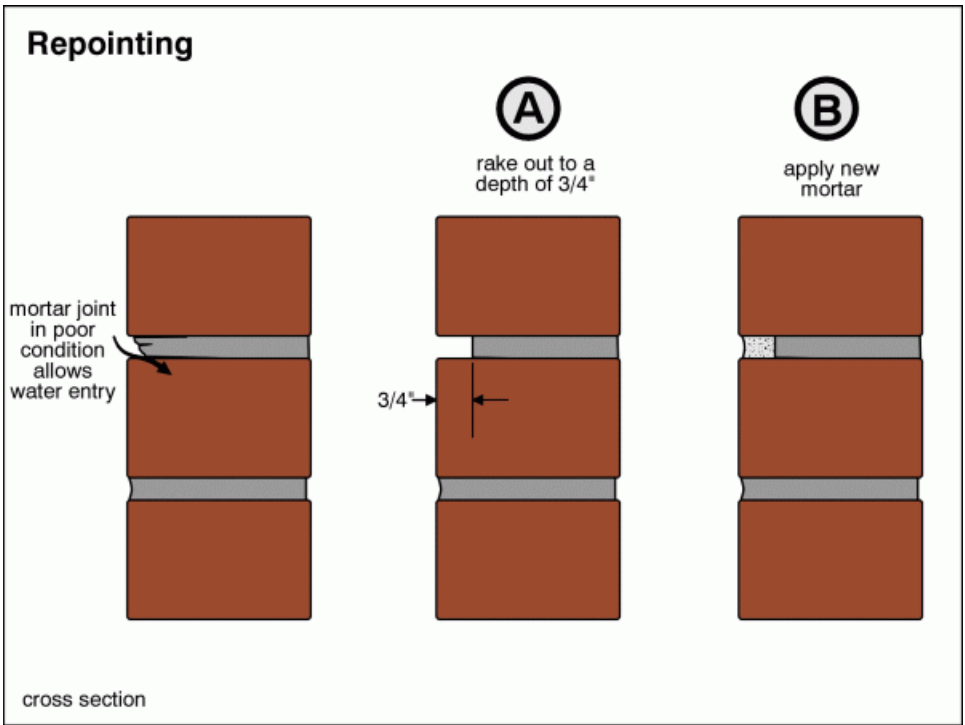
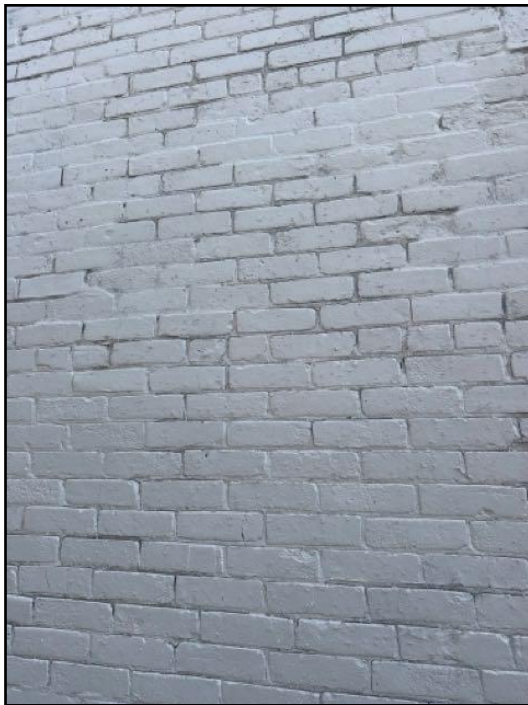
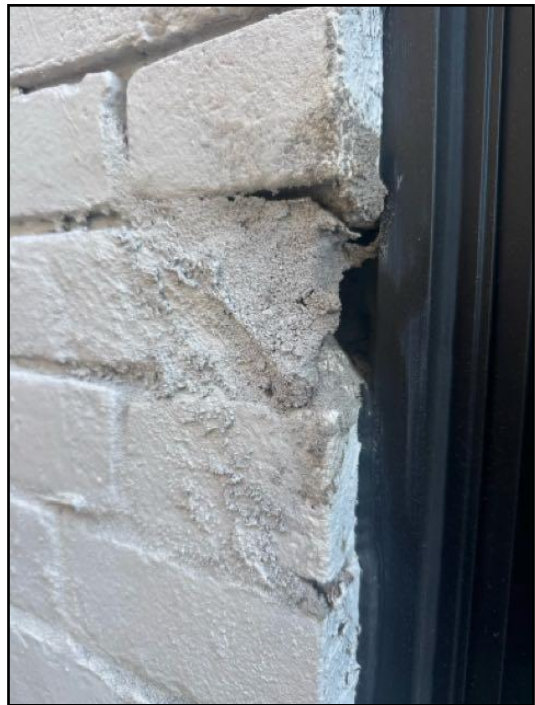
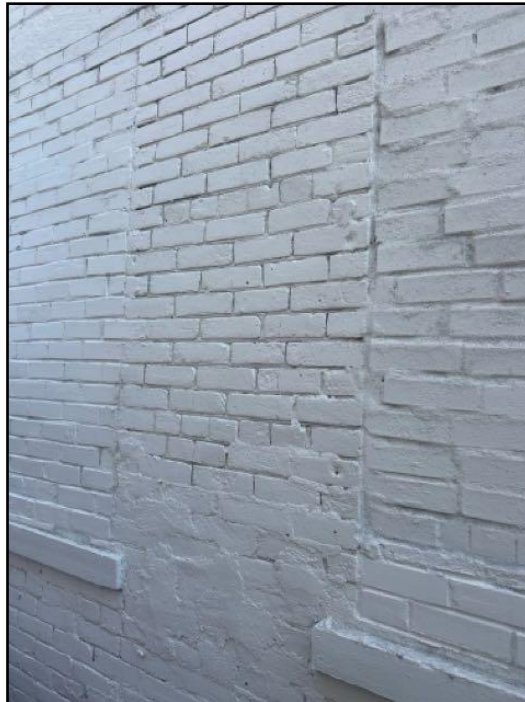
6. Condition: • Mortar deterioration

Tuckpointing is needed to repair deteriorated mortar and seal the building envelope to help prevent water intrusion. This process involves removing damaged mortar and replacing it with fresh mortar. Regular tuckpointing is a normal part of owning a masonry home and is typically needed every 7-10 years. I recommend having a qualified masonry professional evaluate and repair the mortar as needed.

15. Mortar deterioration

16. Mortar deterioration

17. Mortar deterioration

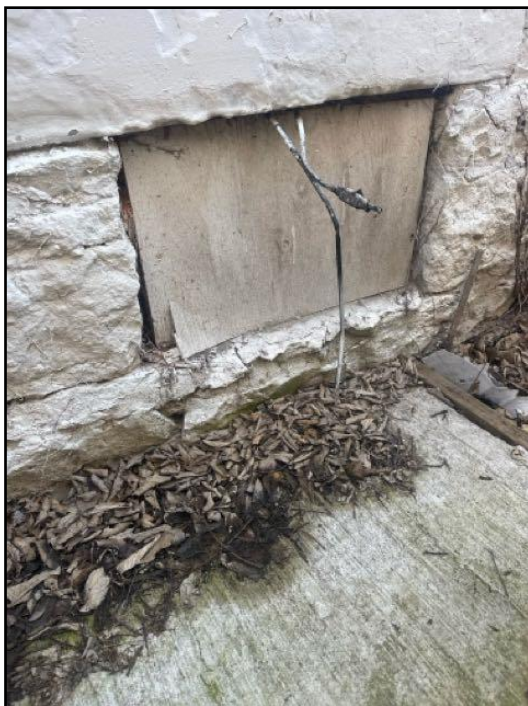
7. Condition: • The windows are currently sealed shut. Adding operable windows would improve ventilation, natural light, and provide an additional means of egress.

18. The windows are sealed shut. This lack of...

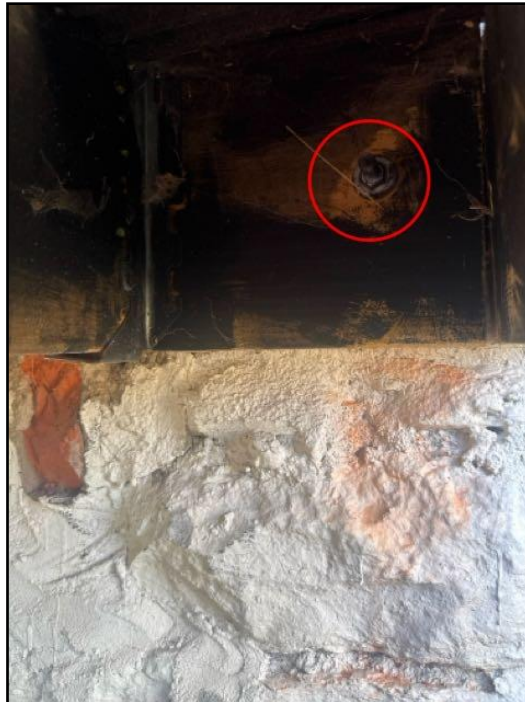
8. Condition: • [Ledgerboard problems](#)

The deck ledger board is fastened with improper fasteners. Ledger boards should be secured with ½-inch diameter bolts or lag screws into solid wood or masonry to safely support the porch. I recommend having a qualified contractor evaluate and upgrade the fasteners as needed.

20. Fastener problems

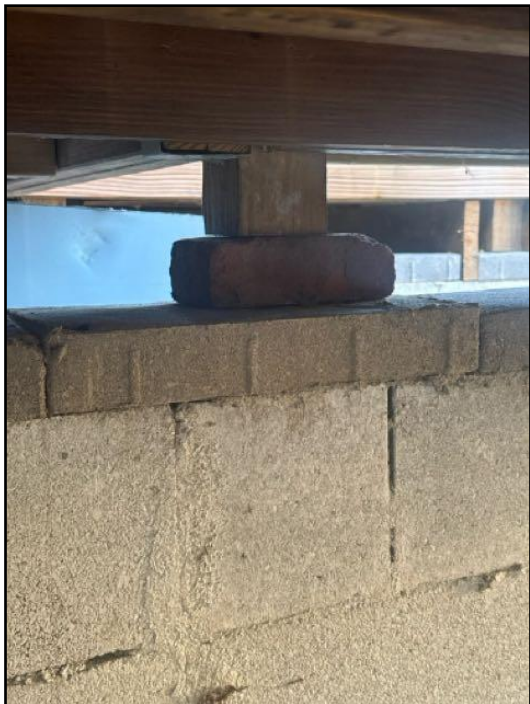
21.

9. Condition: • The masonry wall under the rear two-story deck is supporting beams and joists, but there are no ties or connections between the beams and the loose bricks on top of the wall. I recommend installing proper ties if this wall is to carry or transfer a load. Making these improvements will help ensure long-term stability and minimize movement of the structure.

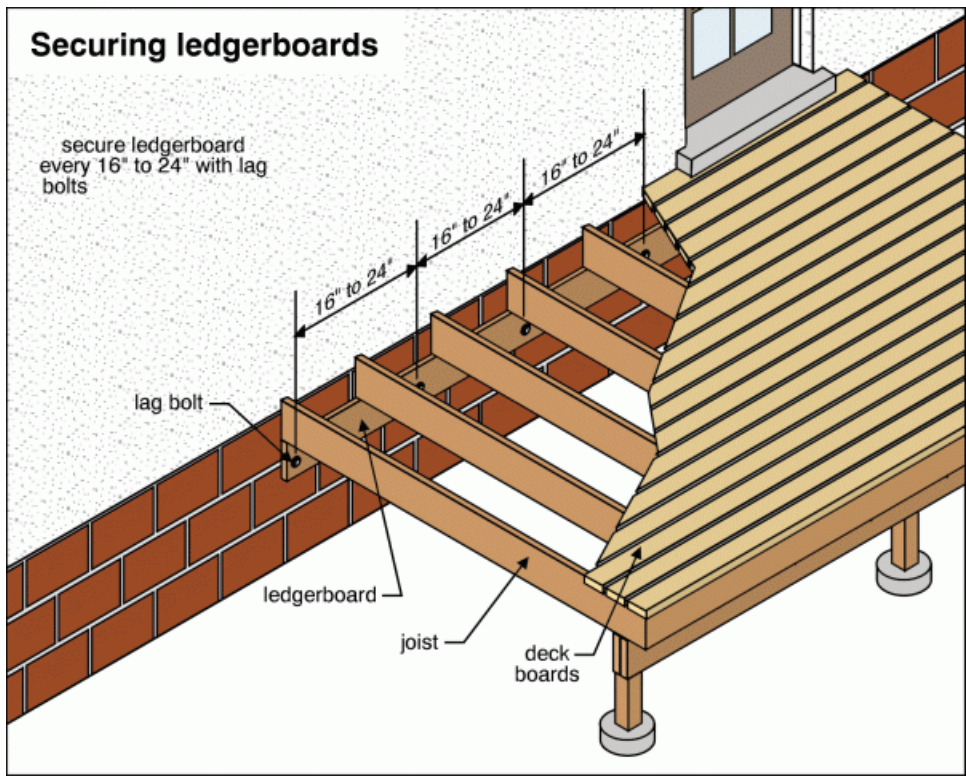
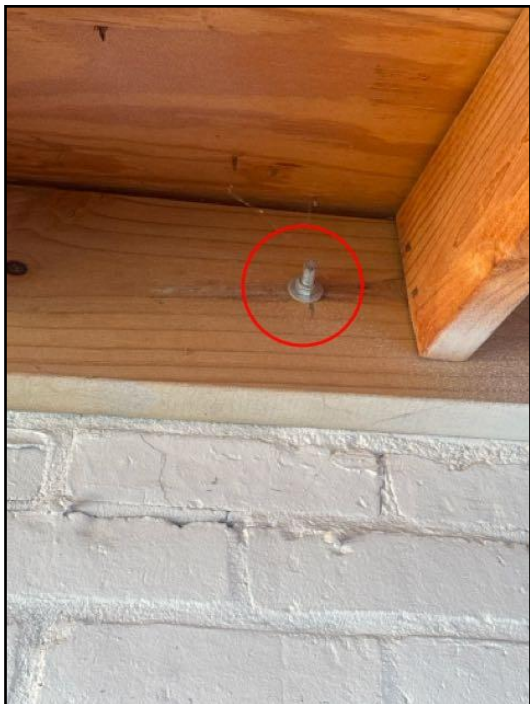
10. Condition: • The front porch ledger board is fastened with improper fasteners. Ledger boards should be secured with ½-inch diameter bolts or lag screws into solid wood or masonry to safely support the porch. I recommend having a qualified contractor evaluate and upgrade the fasteners as needed.

23. The front porch ledger board is fastened...

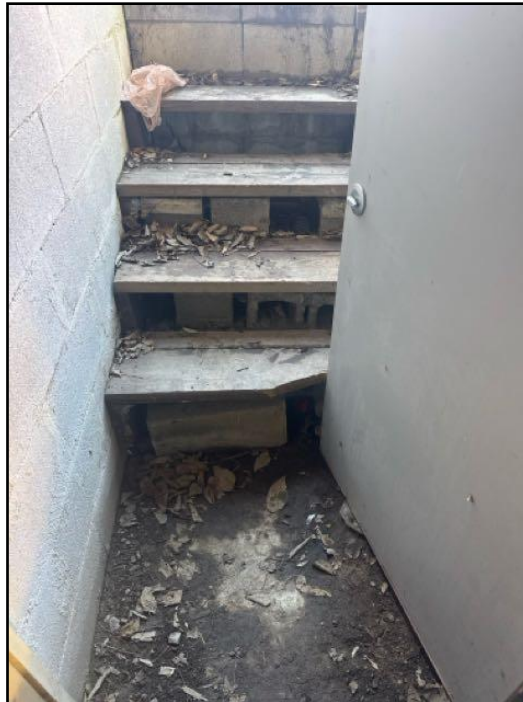
11. Condition: • [Drains missing, clogged or undersized](#)

A basement entry door from the exterior requires a drain to prevent water damage to the structure. I recommend

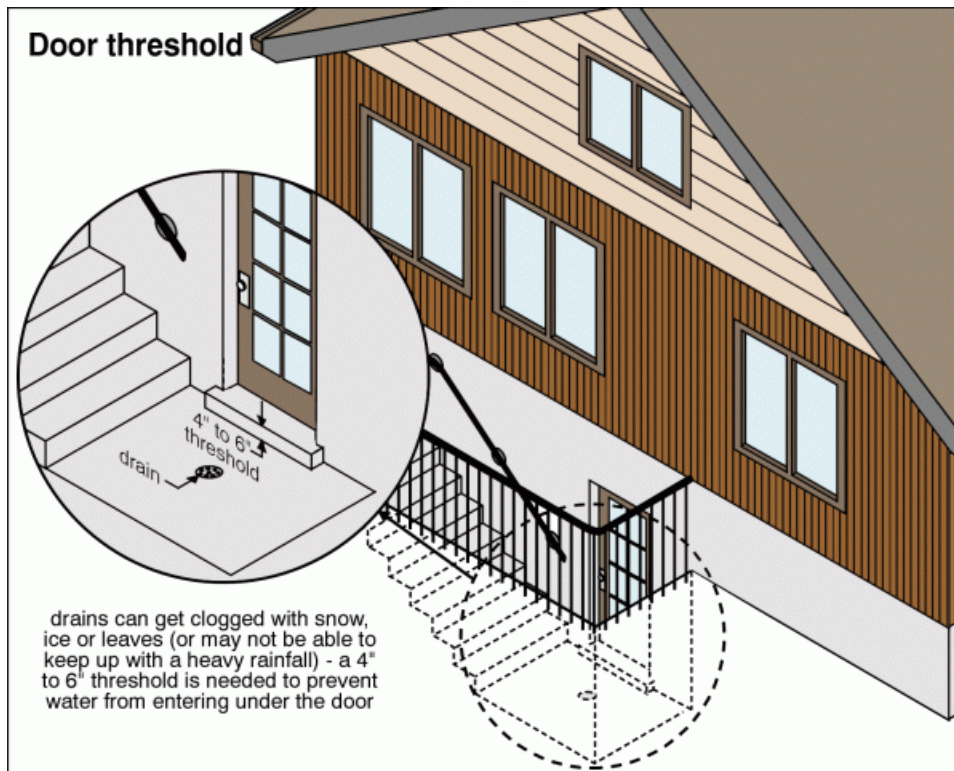
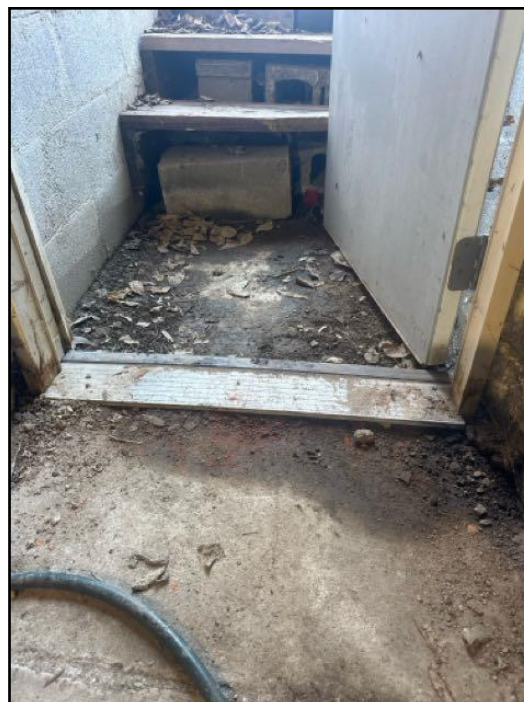
12. Condition: • [Door threshold missing, too low, not watertight](#)

The threshold is not providing adequate water deflection. I recommend a qualified contractor evaluate the current workmanship and make improvements as needed.

26. Door threshold missing, too low, not...

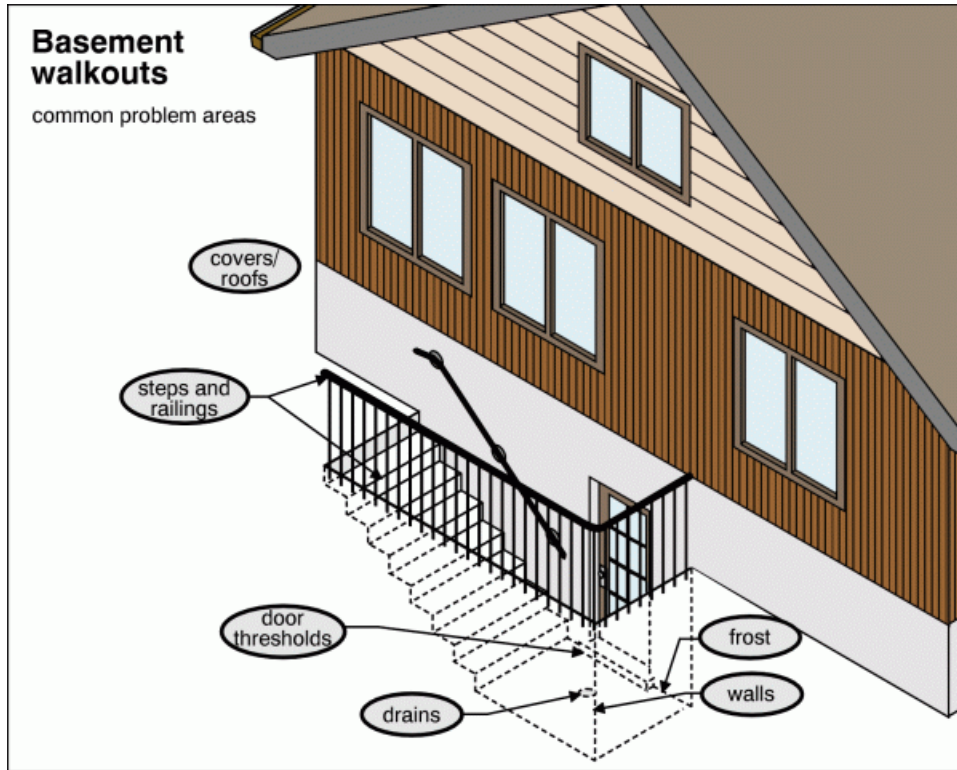
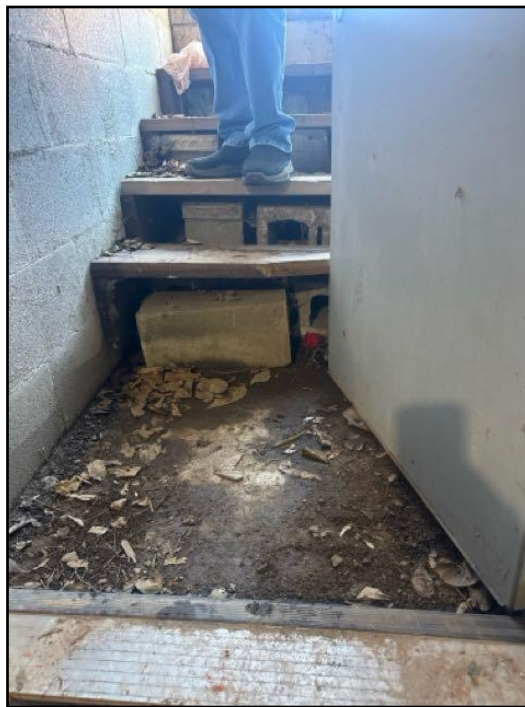
13. Condition: • The basement stairs are not uniform, with varying riser heights and tread depths. Risers should be about 8" inches, treads 10-11 inches, and the variance between steps should not exceed 3/8 inch. I recommend having a qualified contractor evaluate and adjust the stairs to ensure consistency and safety.

27. The basement stairs are not uniform, with...

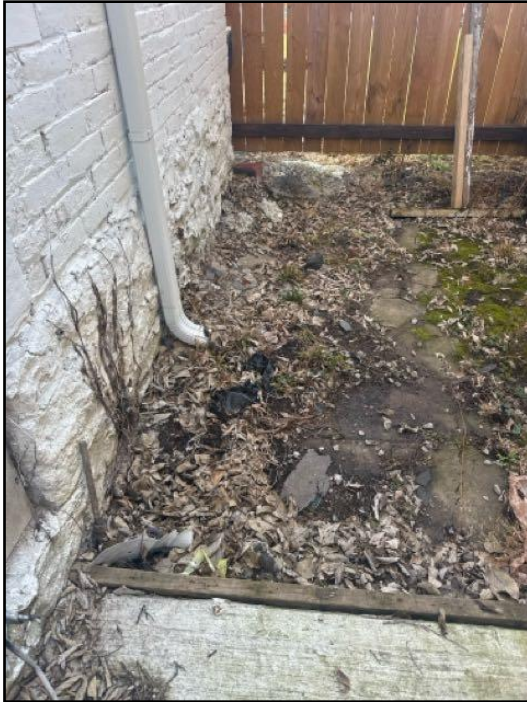
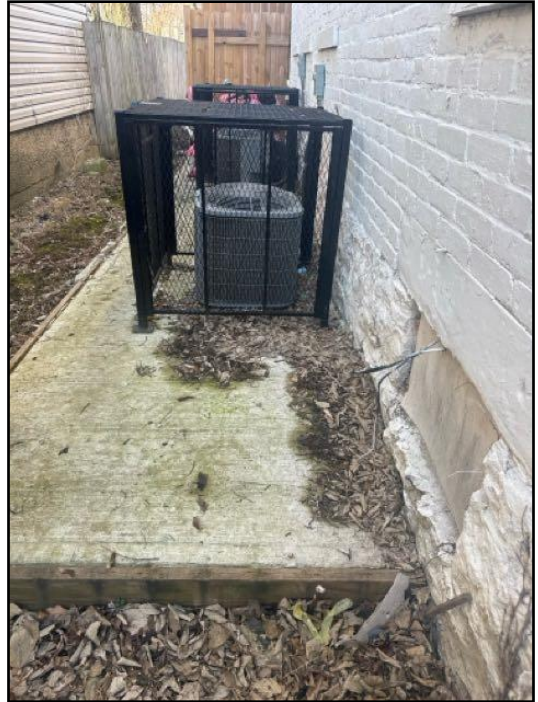
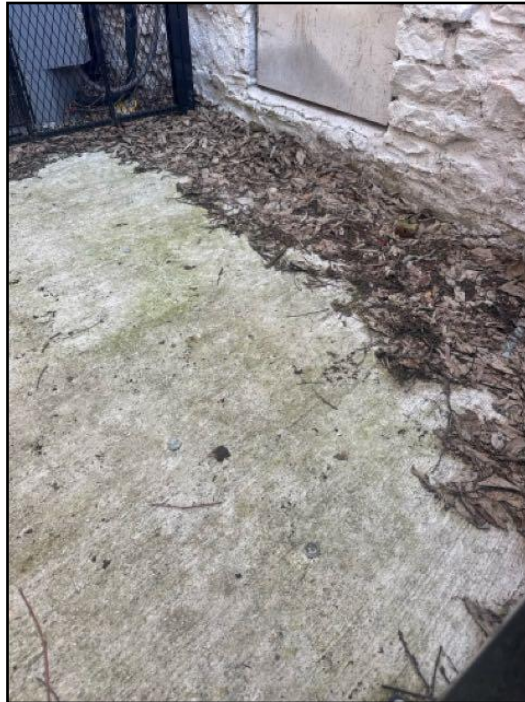
14. Condition: • [Improper slope or drainage](#)

28. *Improper slope or drainage*

29. *Improper slope or drainage*

30. *Improper slope or drainage*

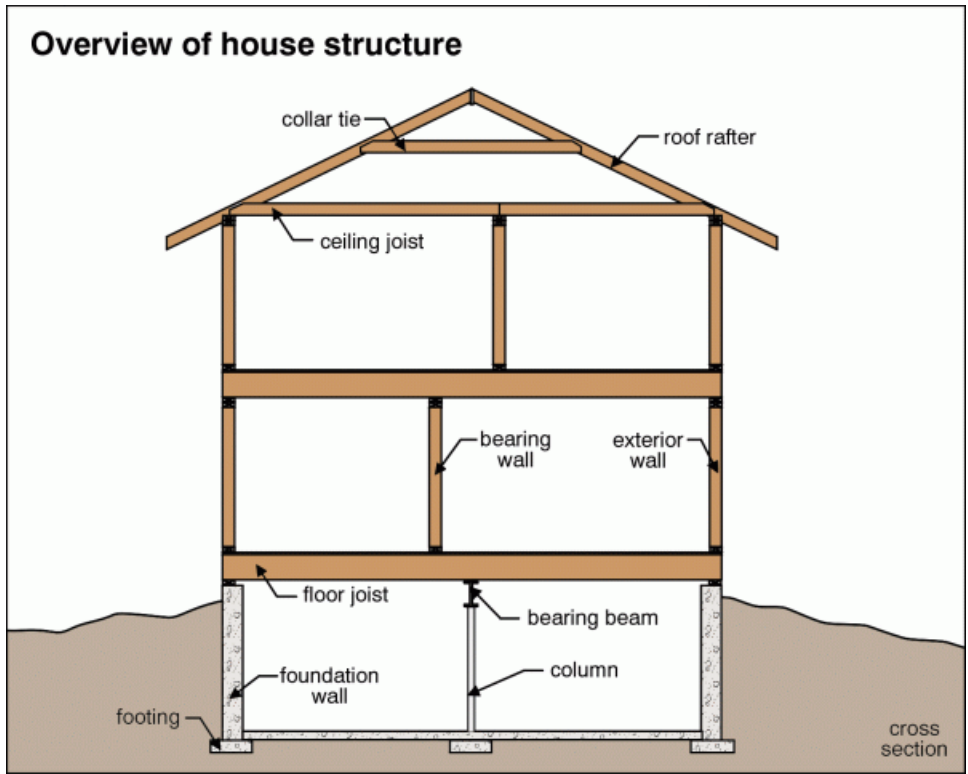
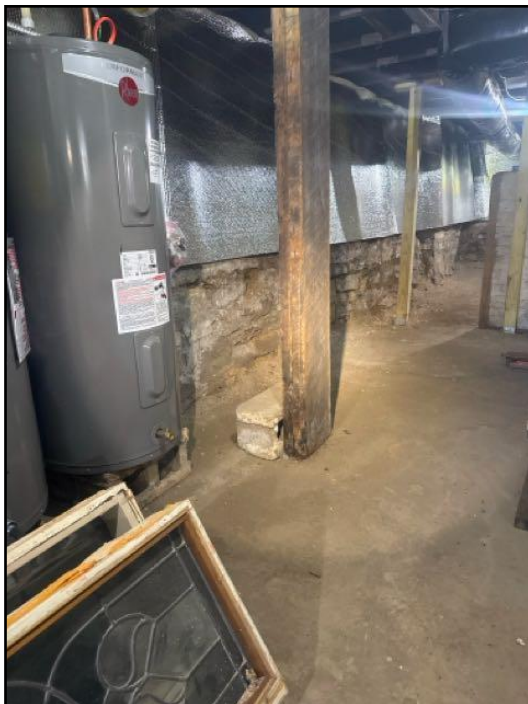
15. Condition: • [No footing](#)

The purpose of a footing is to support posts, piers, or foundation walls by distributing their load to the ground. This home has areas where footings are undersized or absent beneath the slab, which can allow minor structural movement over time. While this has likely been in place for many years without issue, I recommend monitoring for any movement and consulting a qualified contractor if repairs become necessary.

31. No footing

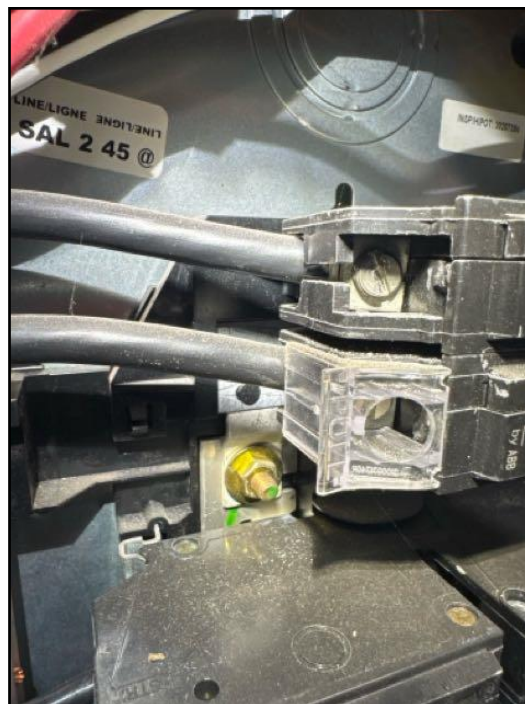
18. Condition: • [Anti-oxidant missing on aluminum wire](#)

The aluminum wires were missing anti-oxidant gel. Aluminum service wires can become very hot and also corrode over time. It is crucial to apply an anti-oxidant gel to the wires where they meet the main lugs, bus or breakers of the service panel. Applying this gel is cheap and easy but sometimes overlooked.

45. Anti-oxidant missing on aluminum wire

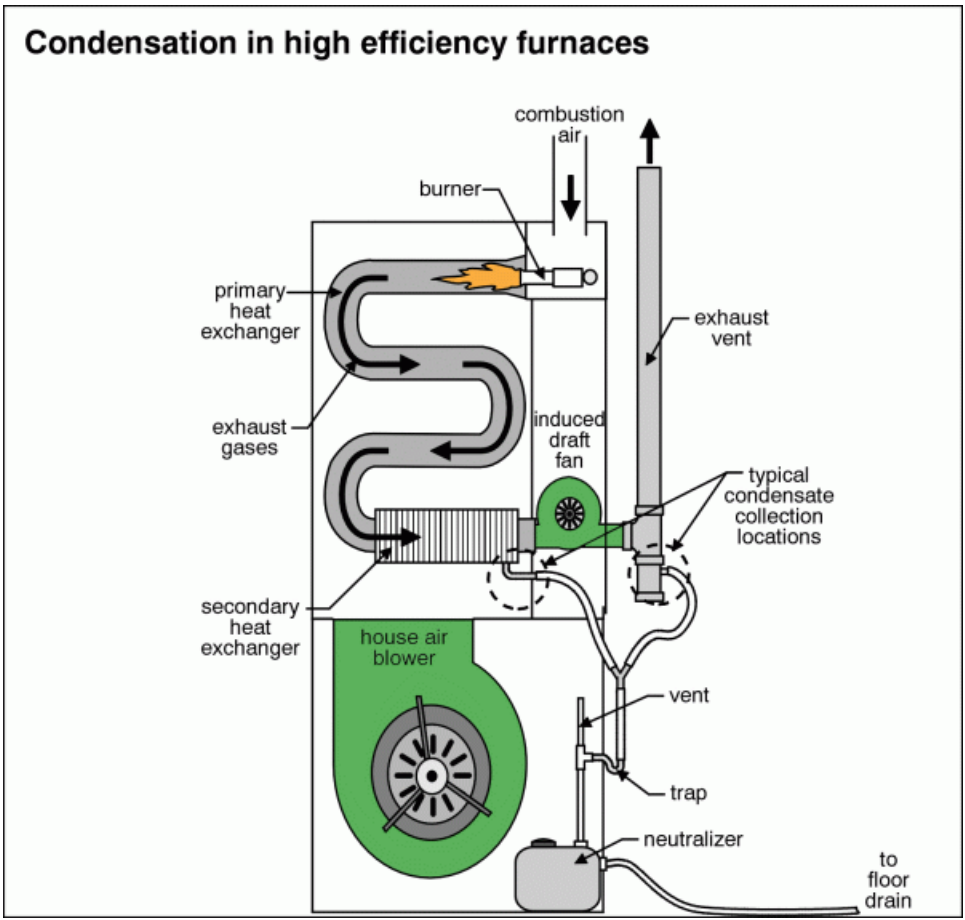
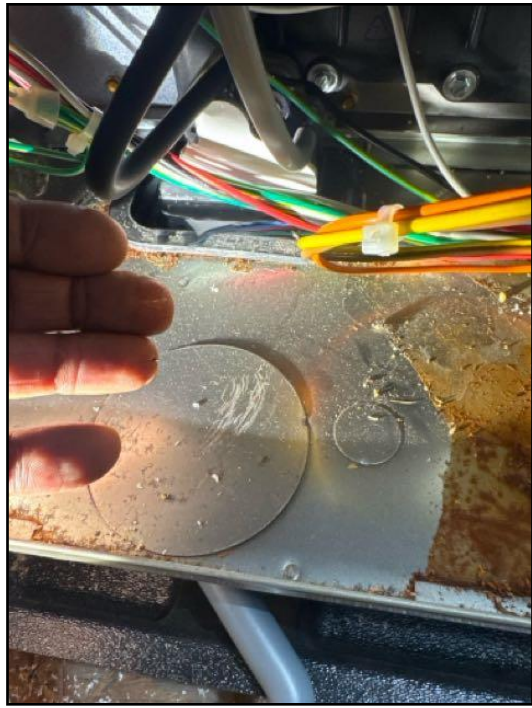
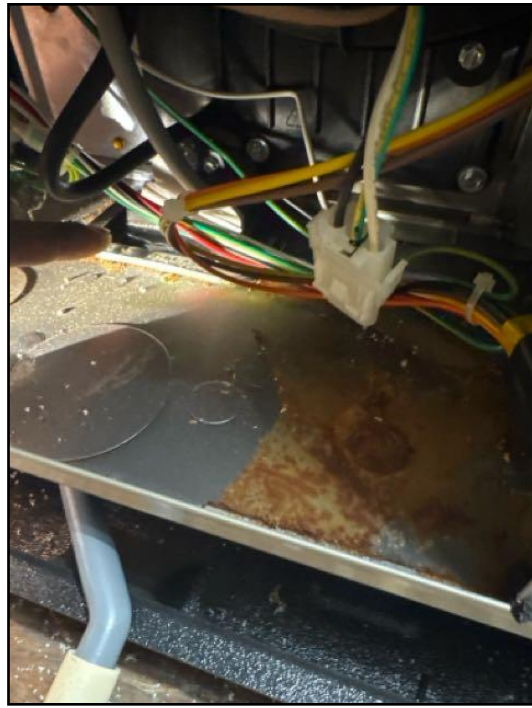
21. Condition: • [Condensate leak](#)

During the inspection, rust and corrosion were observed at the bottom of the furnace, likely due to moisture accumulation from the condensation system, potentially caused by a failed coil gasket or blocked condensate lines. I recommend promptly repairing the coil gasket and ensuring the condensate lines are clear and properly sloped to prevent further moisture issues. Regular maintenance checks should also be scheduled to monitor for any recurrence of the problem.

57. Condensate leak

58. Condensate leak

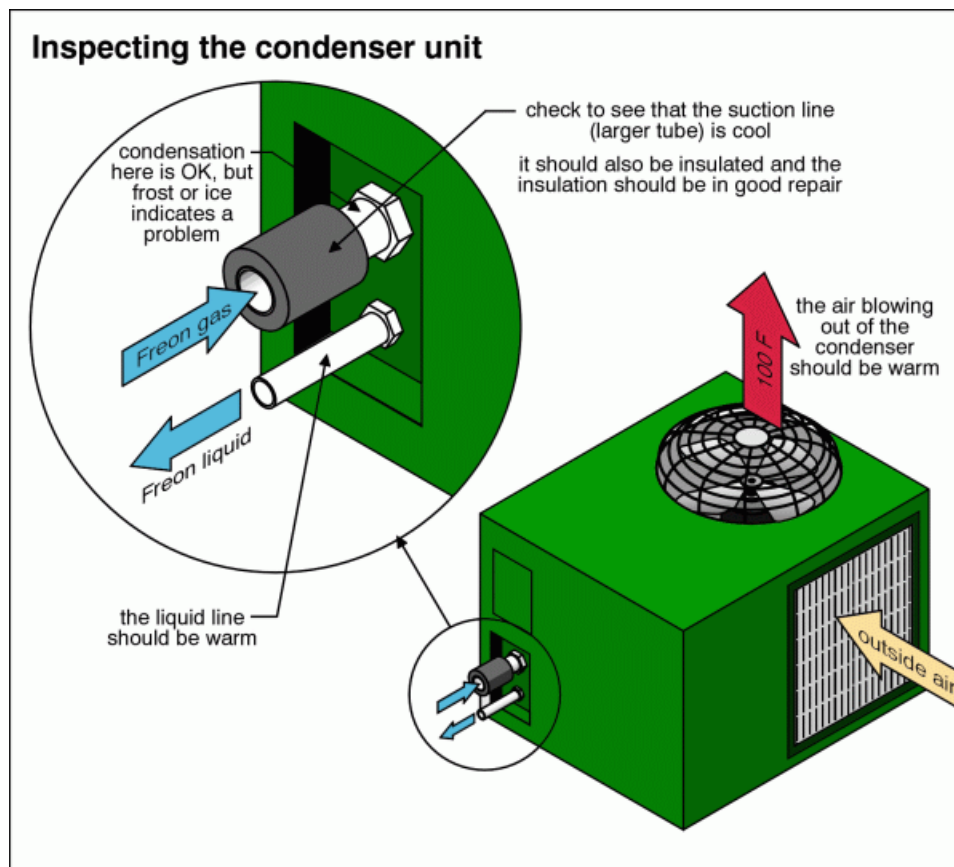
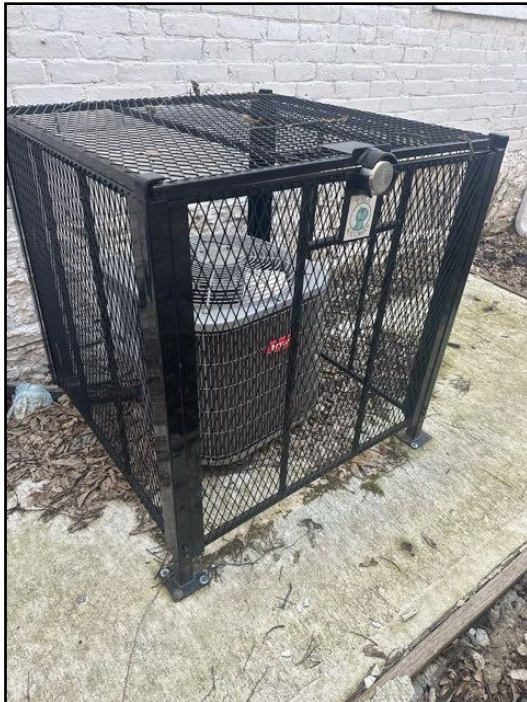
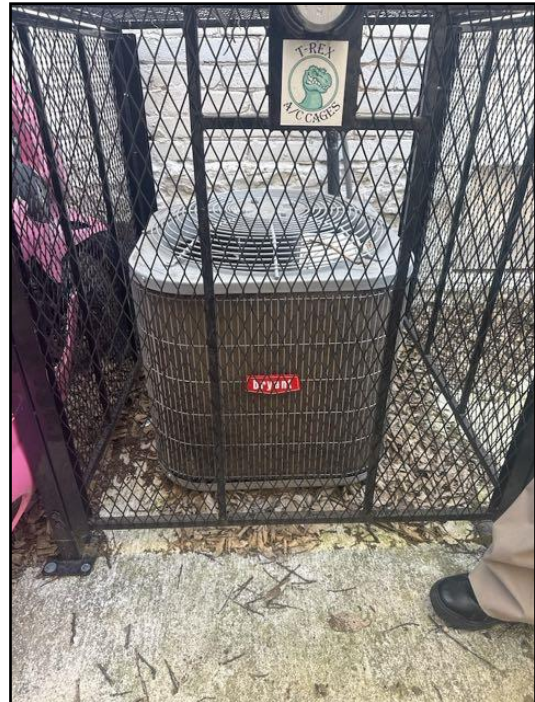
22. Condition: • Dirty

One of the ways in which a dirty condenser coil will affect an air conditioner is to reduce the overall efficiency of the unit. With a condenser coil that is dirty or blocked, the unit will have to work harder to achieve the same results. When the efficiency of the air conditioner is reduced, the unit will also cost the owner more money to operate. Reduced efficiency means that the unit must work harder which requires more electricity and in turn, this will result in higher utility bills.

63. Dirty

64. Dirty

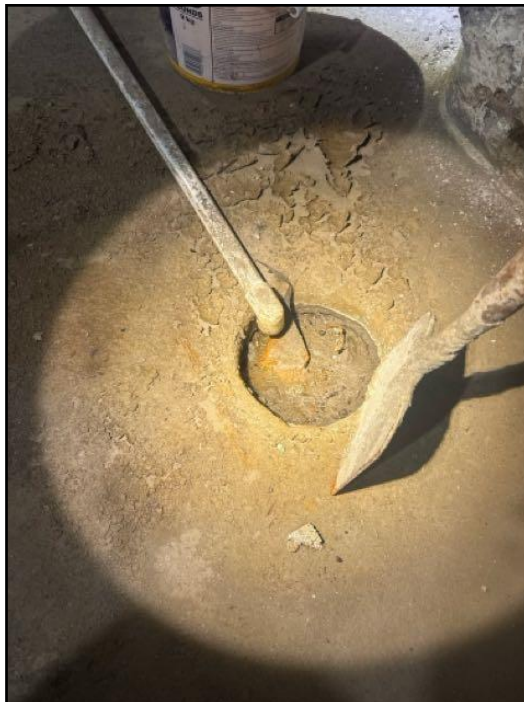
24. Condition: • [Obstructed](#)

The floor drain is clogged, I recommend contacting a licensed plumber for further evaluation to make any and all repairs needed.

75. *Obstructed*

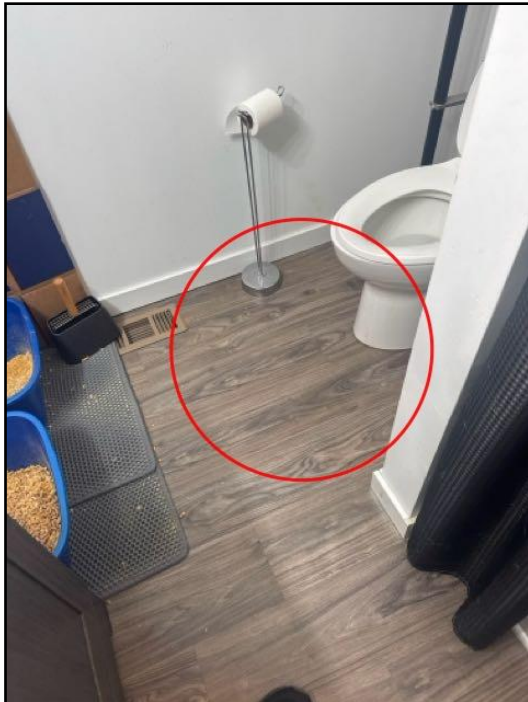
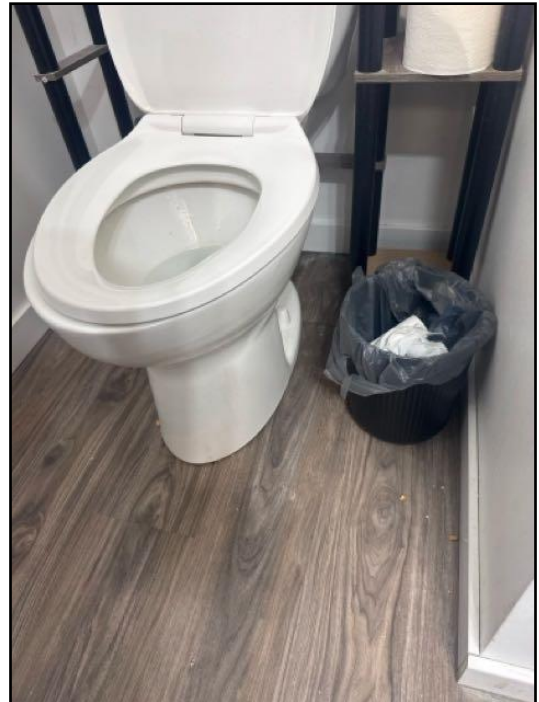
25. Condition: • [Floor damage suspected](#)

The toilet has leaked in the past, and the floor near the toilet shows a slight sag or soft spot. While there is no evidence of an active leak at this time, this condition may indicate previous damage to the subfloor or framing. I recommend consulting the current owner to confirm any prior repairs and ensure the issue has been properly addressed.

76. Floor damage suspected

77. Floor damage suspected

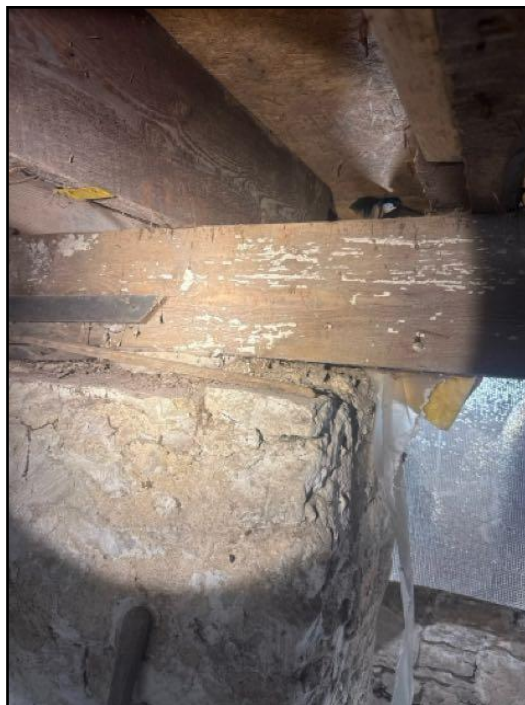
26. Condition: • [It has been determined that this structure was built before 1978 and therefore stands the risk of having lead base paint present.](#) Effective April 22, 2010 any renovation of structures built before 1978 with children under 6, day care centers, and learning facilities with children under 6 must be done by "Certified LBP Contractors" and they must follow a set of published procedures. It has been determined that this structure was built before 1978 and therefore stands a high risk of lead base paint present. The work exceeding 6 SQ FT of demolition on more than 20 SF of painting per room. Under the EPA ruling CFR Part 745 effective April 22, 2010, any renovation, remodeling or painting must be done by a certified contractor following lead safe practices and this could lead to higher prices than similar contracts performed on structure that do not have lead base paint present. It is recommended that a preliminary screening for lead base paint be conducted to determine the likelihood of the presence of lead before closing. Part of the procedure is for a licensed lead-based paint inspector to provide a LBP component test of the structure.

78. *It has been determined that this structure...*

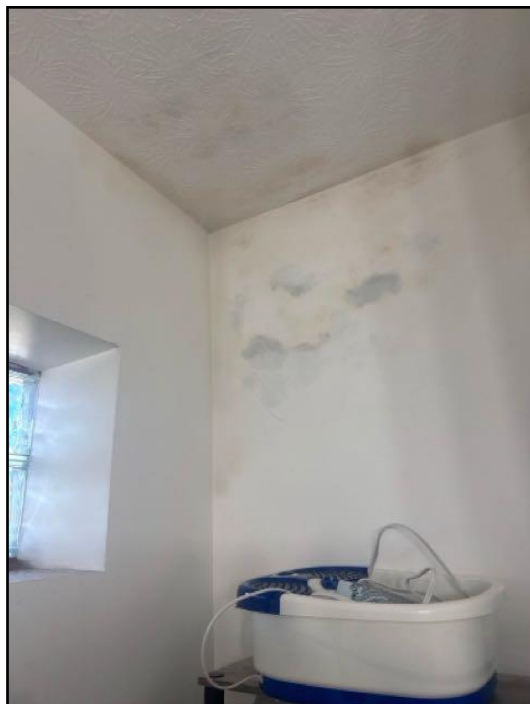
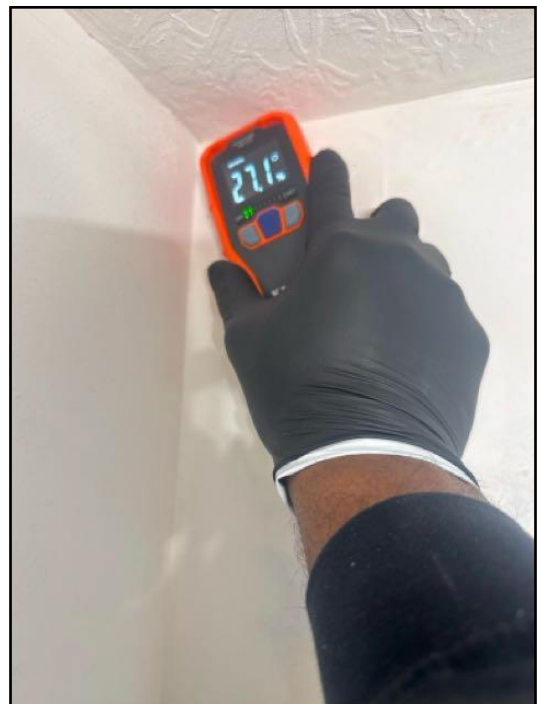
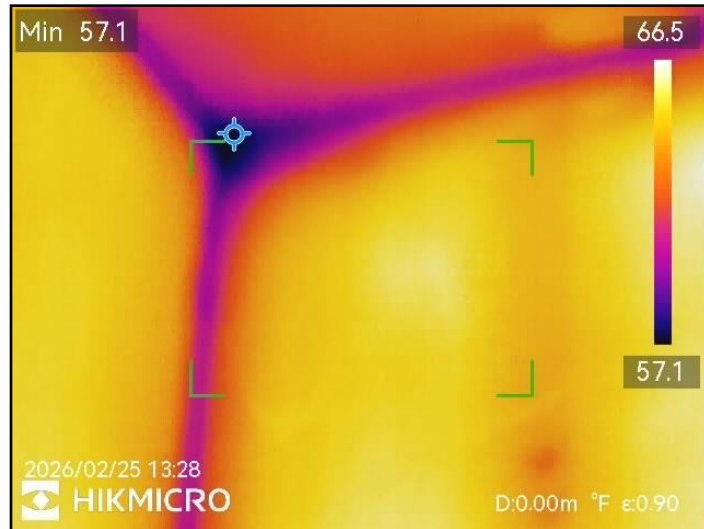
28. Condition: • [Water damage](#)

Water damage was observed on the ceiling, either as visible staining or as a temperature anomaly detected with a thermal imaging camera. This anomaly was then confirmed using a moisture meter, indicating that the leak is currently active. This inspection is limited, and non-invasive testing was used; exhaustive or destructive methods were not performed. Future leaks may occur, and I recommend having a qualified contractor evaluate the source of the water and make necessary repairs.

82. Water damage

83. Water damage

84. Water damage

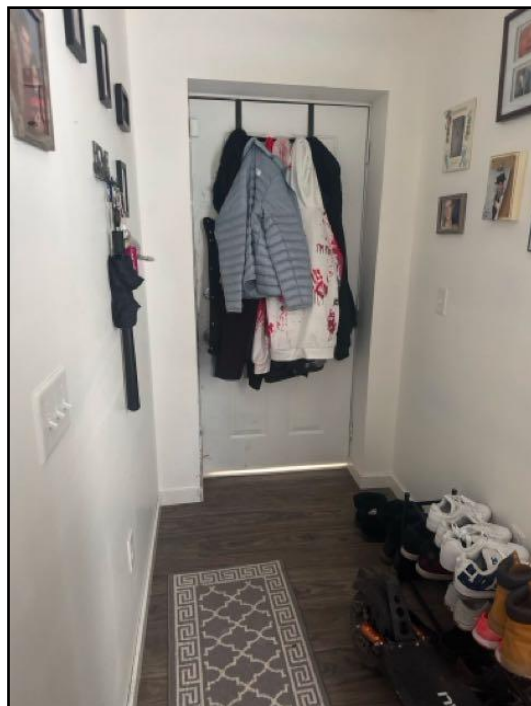
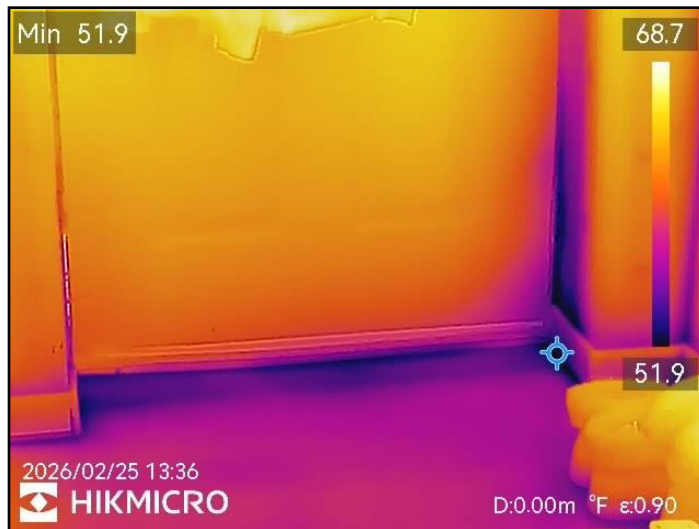
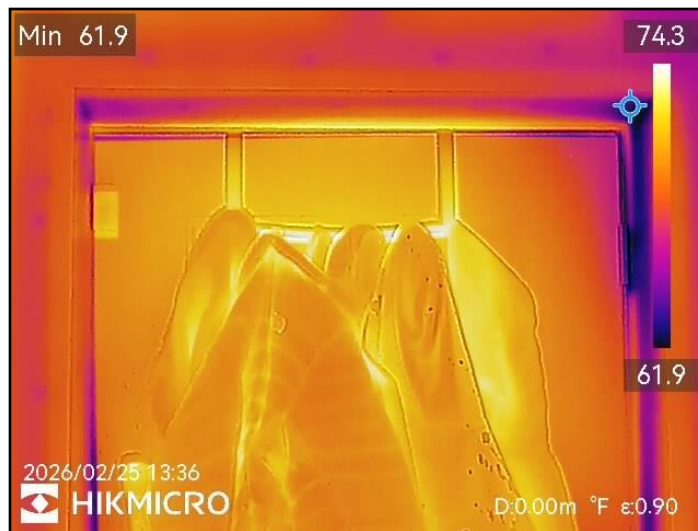
30. Condition: • [Weatherstripping missing or ineffective](#)

86. Weatherstripping missing or ineffective

87. Weatherstripping missing or ineffective

88. Weatherstripping missing or ineffective
