INSPECTION REPORT

For the Property at:
69 CHICAGO AVE
COLUMBUS, OH 43222

Prepared for: MATTHEW HONDA
Inspection Date: Wednesday, February 25, 2026
Prepared by: James Jones Licensed

Report No. 12911

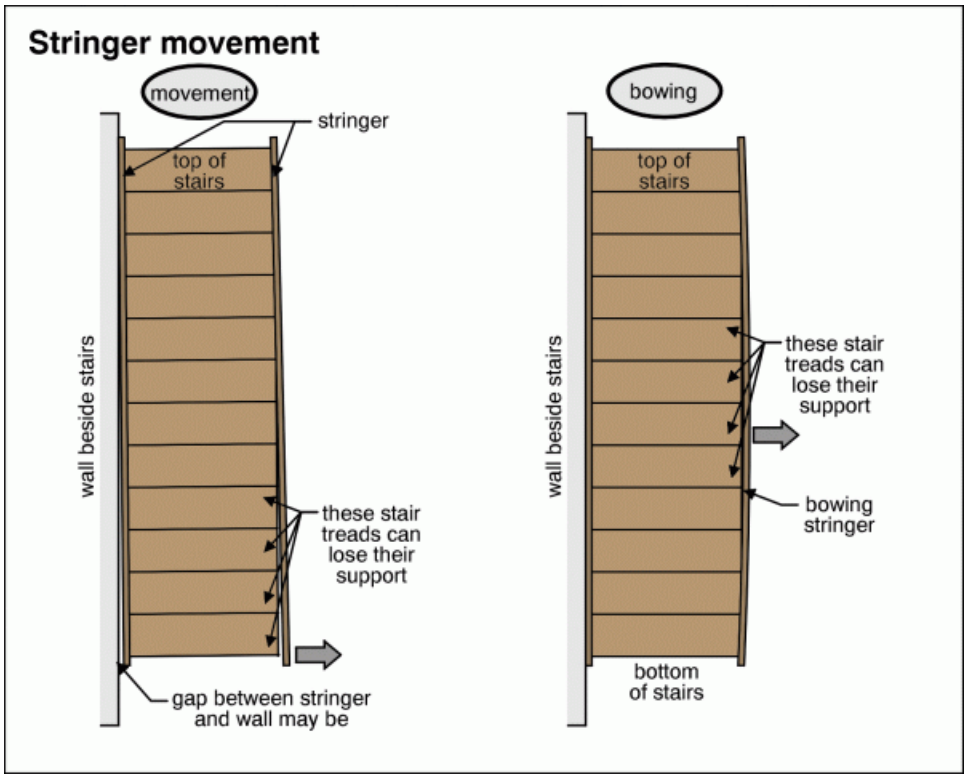
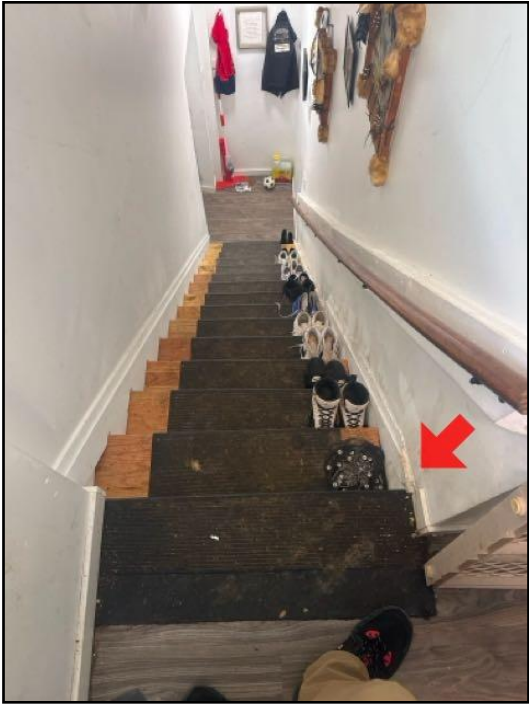
89. The building shows sign of structural...

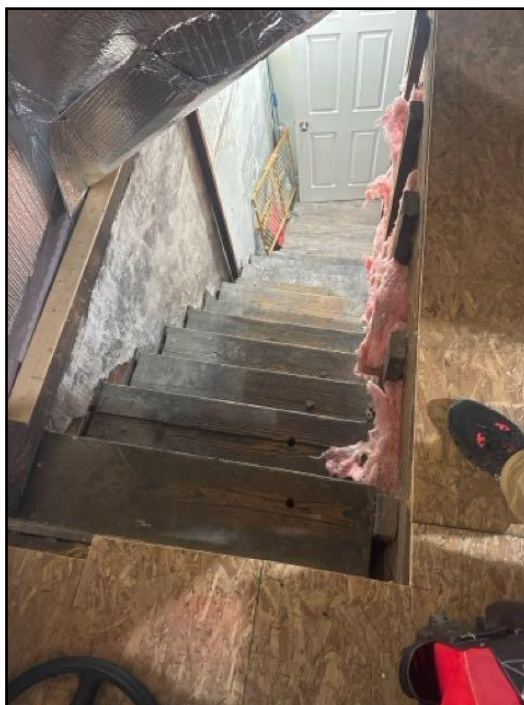
32. Condition: • [Worn or damaged](#)

The tread is damaged, I recommend repairing the step to improve occupant safety.

90. Worn or damaged

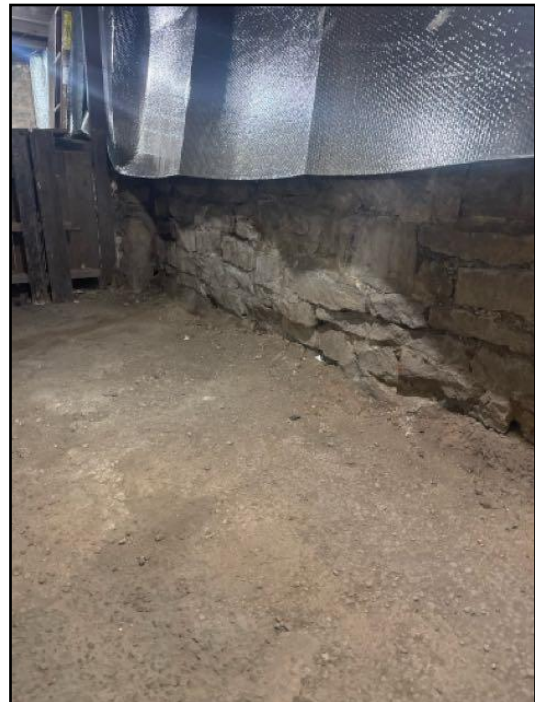
94. You need to be aware basements below grade...

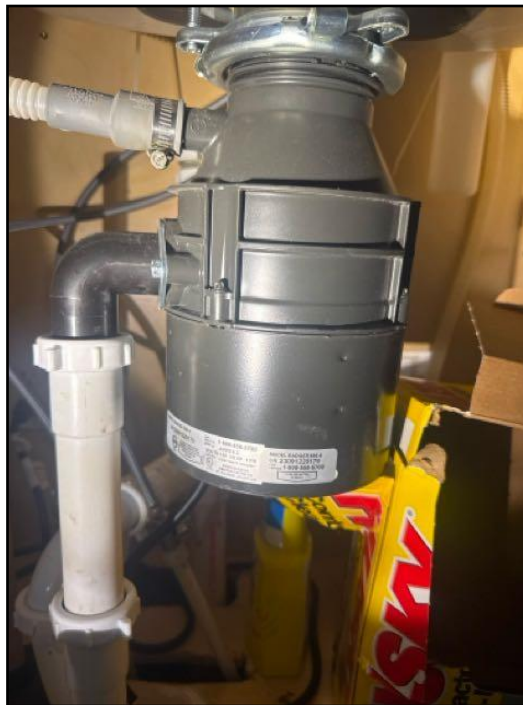
98. *Inoperative*
