INSPECTION REPORT

For the Property at:
69 CHICAGO AVE
COLUMBUS, OH 43222

Prepared for: MATTHEW HONDA
Inspection Date: Wednesday, February 25, 2026
Prepared by: James Jones Licensed

Report No. 12911

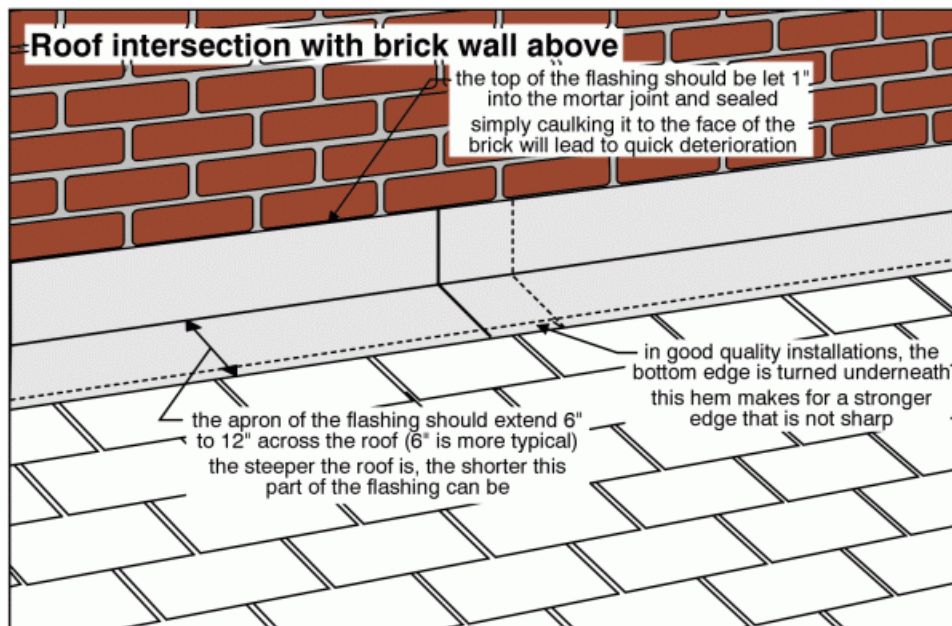
6. Not let into mortar joints

1. Condition: • [Not let into mortar joints](#)

Flashing is critical to the long-term performance of masonry and must be properly detailed to prevent moisture intrusion. Flashing that does not fully extend through the wall and out to the exterior with a proper drip edge is ineffective. It should extend into the mortar joint and be struck tight with mortar - not simply sealed with caulking.

Sealants are considered maintenance materials and will deteriorate over time due to weather and UV exposure. As caulking shrinks or cracks, it can allow water to enter the wall assembly. Mortar, when properly installed around the flashing, provides a more durable and integrated seal.

Implication(s): Chance of water damage to structure, finishes and contents

Location: Wall Flashing

Flashing and counterflashing must be properly lapped and continuous, with all bends and joints fully sealed. I recommend periodic monitoring and having a qualified roofing contractor repair or upgrade the flashing as needed to maintain proper water management.

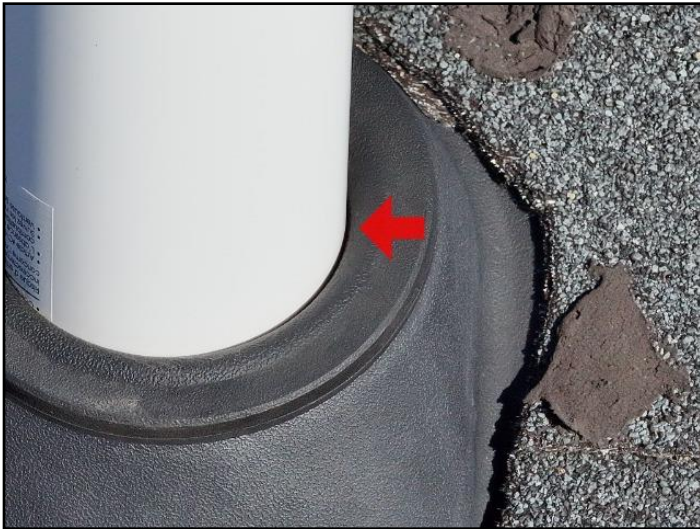
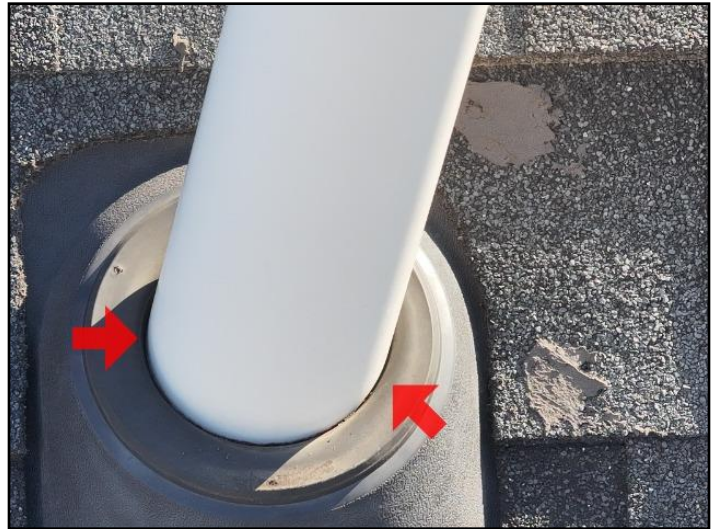
2. Condition: • The pipe boot collars exhibit signs of buckling or stretching, which is typically caused by movement of the piping that protrudes through the penetration collar. This issue may be attributed to inadequate piping support or repairs related the mechanical piping, or even storm-related factors. If the pipe boot is not properly functioning as designed to deflect water, it can lead to water pooling on the boot, which increases the risk of water intrusion. It is evident that the collars are buckled or stretched and require repair or replacement to prevent further issues.

8. The pipe boot collars exhibit signs of...

9. The pipe boot collars exhibit signs of...

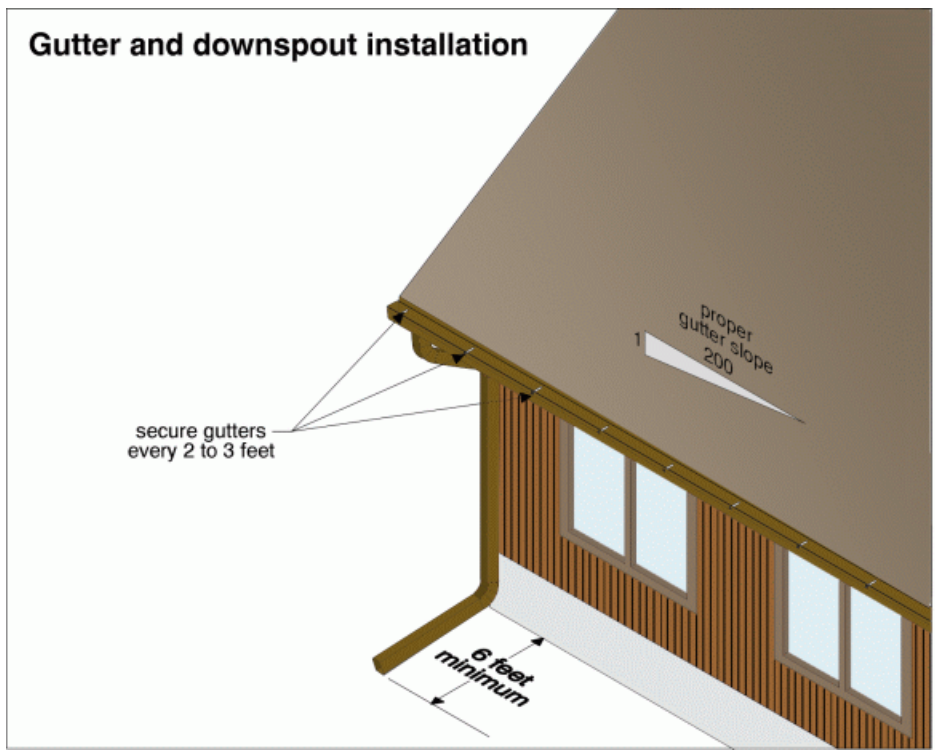
11. Should discharge 6 feet from building

3. Condition: • [Should discharge 6 feet from building](#)

The gutters should be extended six feet beyond the foundation wall. This will prevent hydrostatic pressure from building up around the foundation wall causing the structure to fail and leak. I recommend improving this condition to prevent or stop any water damage to the building.

Implication(s): Chance of water damage to structure, finishes and contents

Location: Various Throughout Building Perimeter

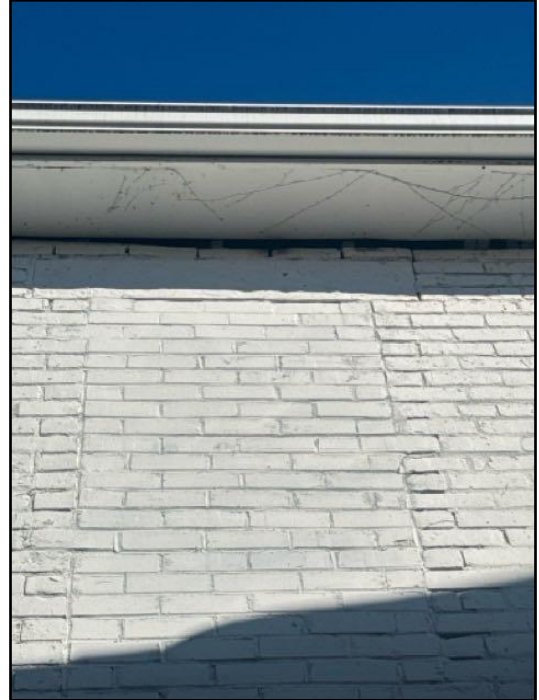
14.

5. Condition: • Open gaps were observed at the perimeter of the soffit. These openings should be sealed to help prevent pest entry into the attic. I recommend installing appropriate trim or frieze boards to close the gaps and improve the overall fit and finish.

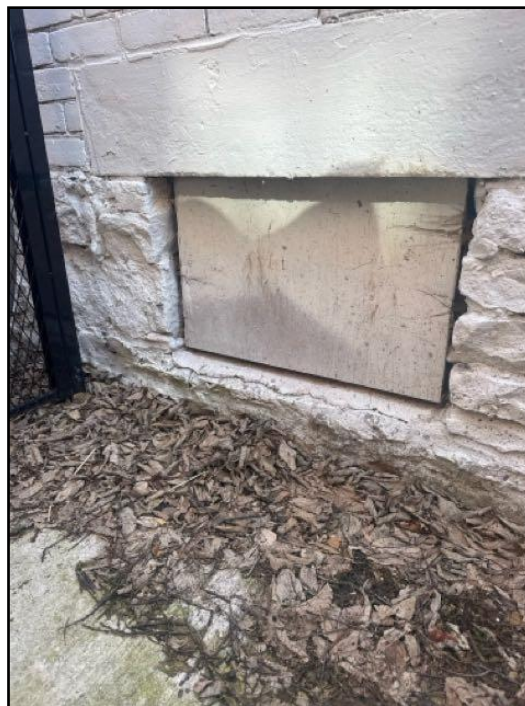
7. Condition: • The windows are currently sealed shut. Adding operable windows would improve ventilation, natural light, and provide an additional means of egress.

19. The windows are sealed shut. This lack of...

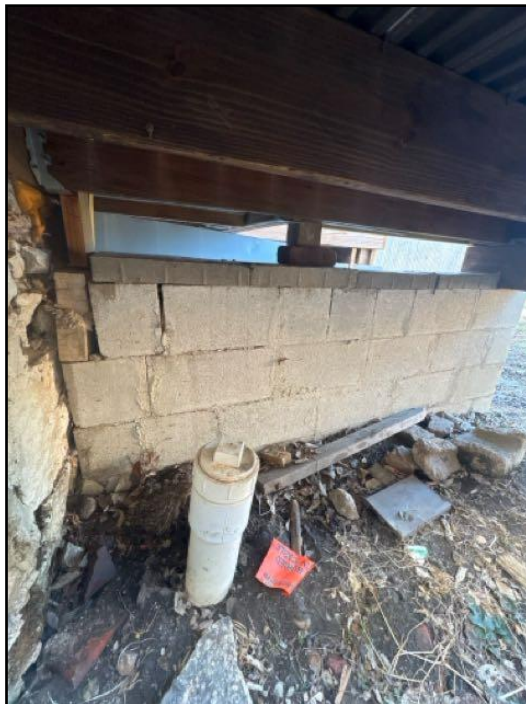
22.

9. Condition: • The masonry wall under the rear two-story deck is supporting beams and joists, but there are no ties or connections between the beams and the loose bricks on top of the wall. I recommend installing proper ties if this wall is to carry or transfer a load. Making these improvements will help ensure long-term stability and minimize movement of the structure.

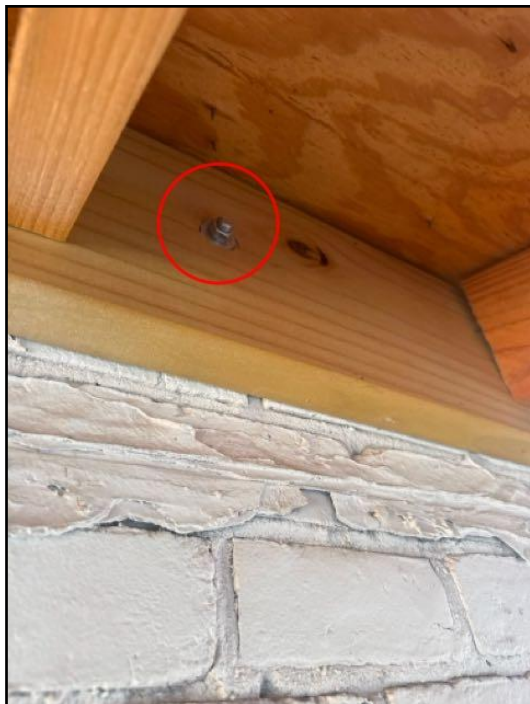
10. Condition: • The front porch ledger board is fastened with improper fasteners. Ledger boards should be secured with ½-inch diameter bolts or lag screws into solid wood or masonry to safely support the porch. I recommend having a qualified contractor evaluate and upgrade the fasteners as needed.

24. The front porch ledger board is fastened...

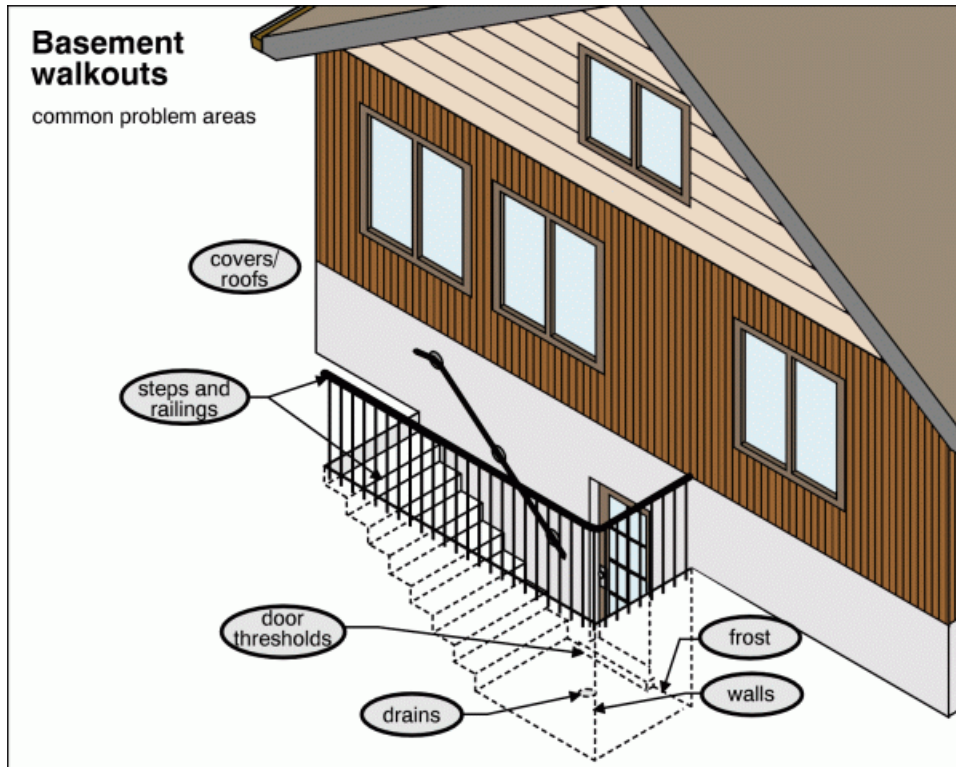
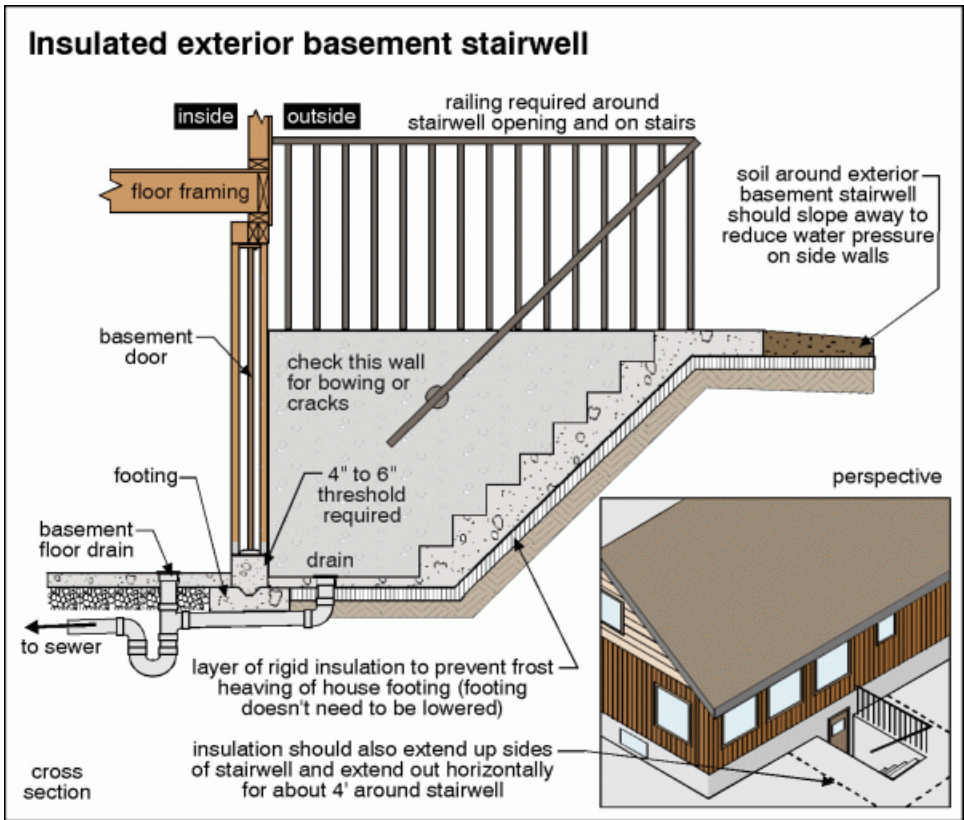
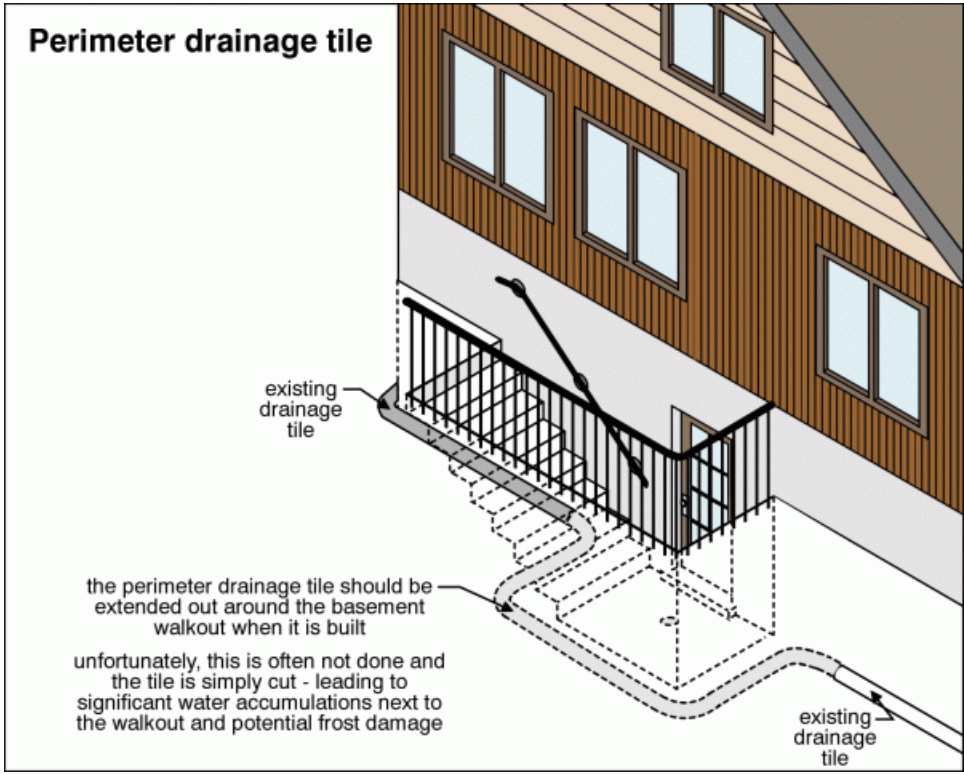
11. Condition: • [Drains missing, clogged or undersized](#)

A basement entry door from the exterior requires a drain to prevent water damage to the structure. I recommend

Implication(s): Chance of water damage to structure, finishes and contents

Location: Basement Walkout

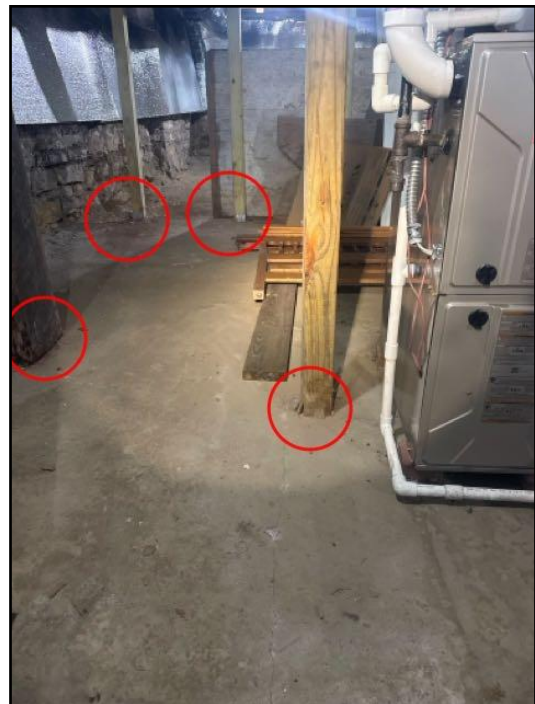
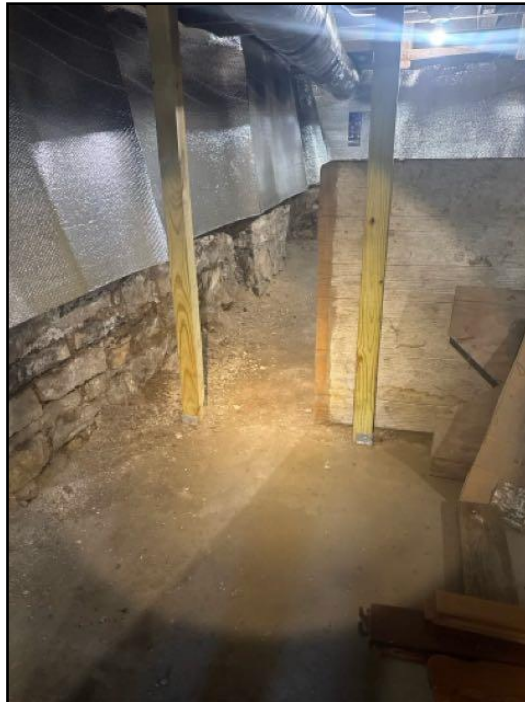
32. No footing

33. No footing

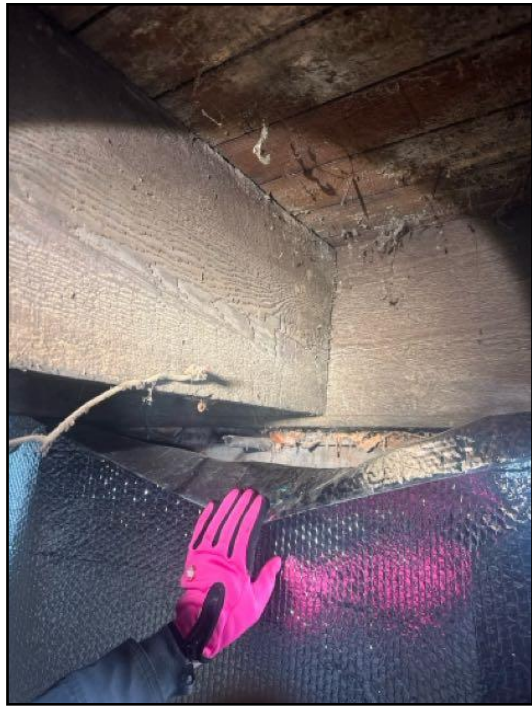
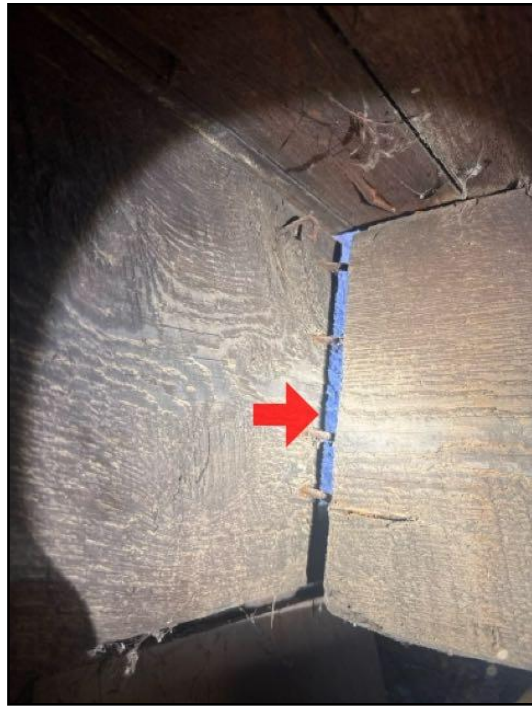
34. Poor end bearing, joist hanger connections

35. Poor end bearing, joist hanger connections

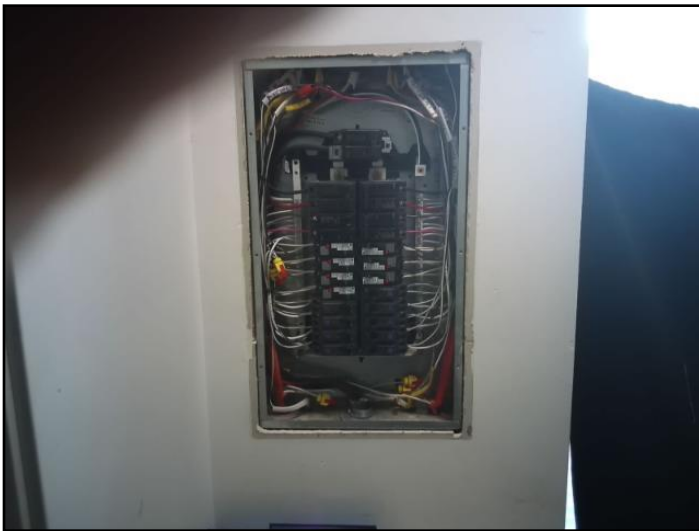
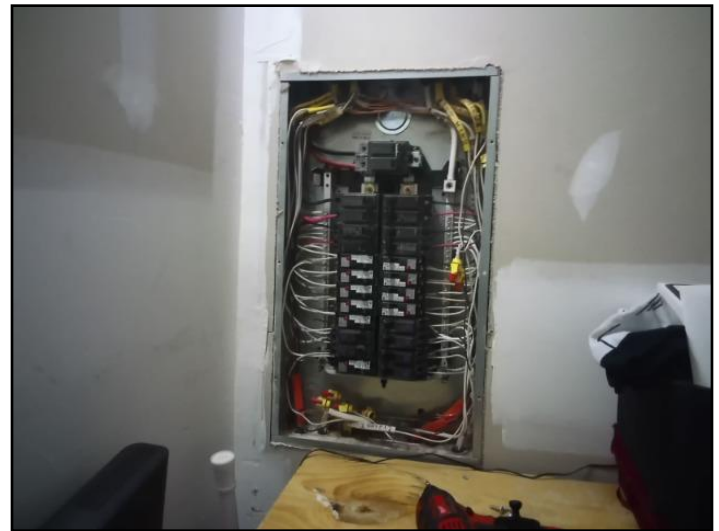
Location: Unit 69 1/2-69

43. Panel is Full- The size of the panel should...

44. Panel is Full- The size of the panel should...

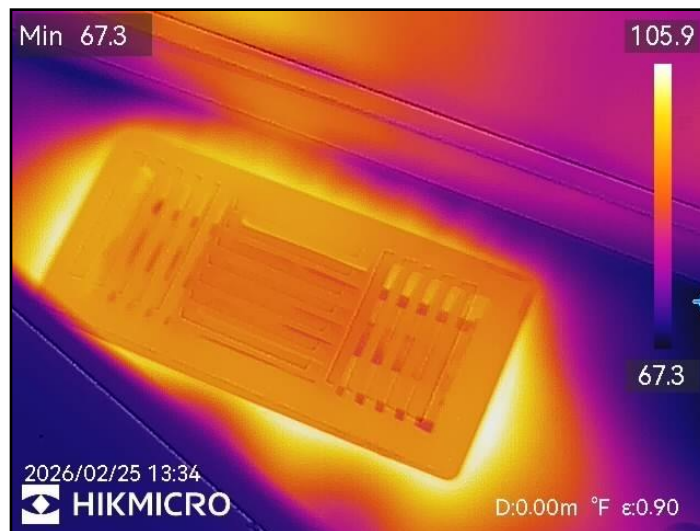
48. 110°

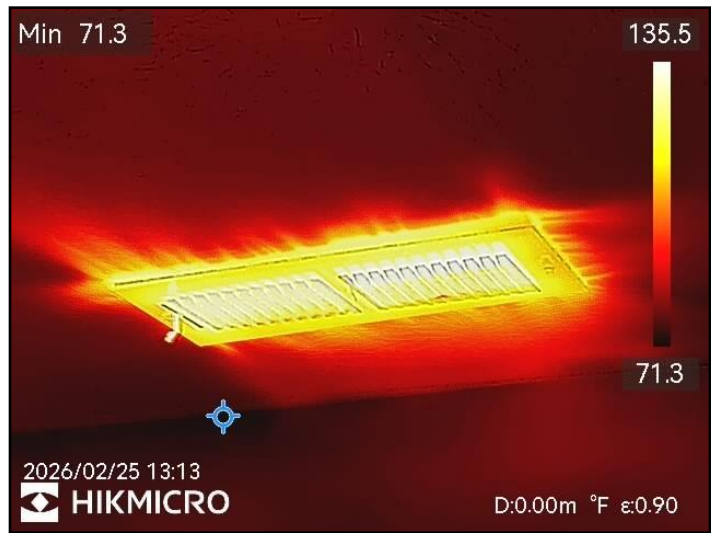
49. 135°

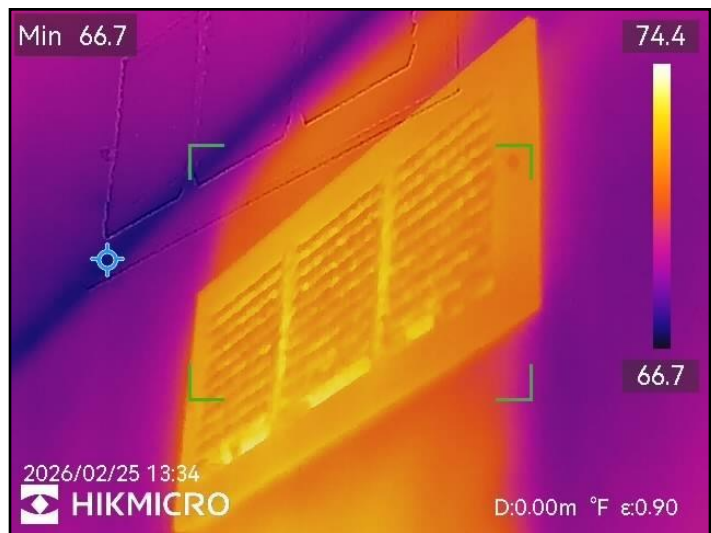
50. 70°

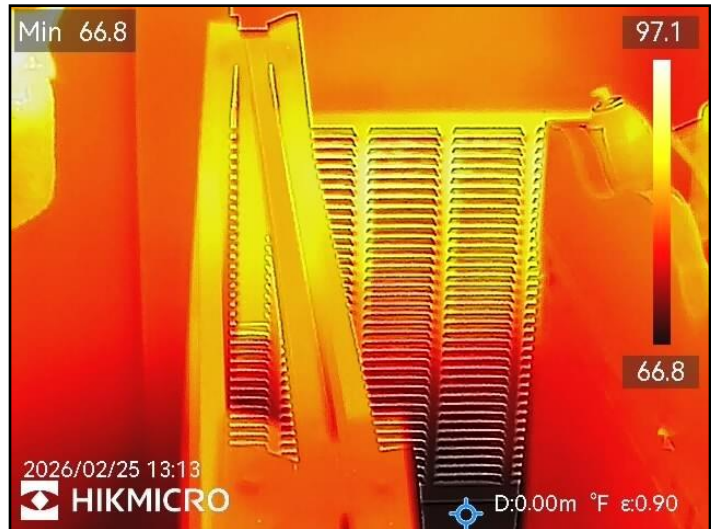
51. 85°

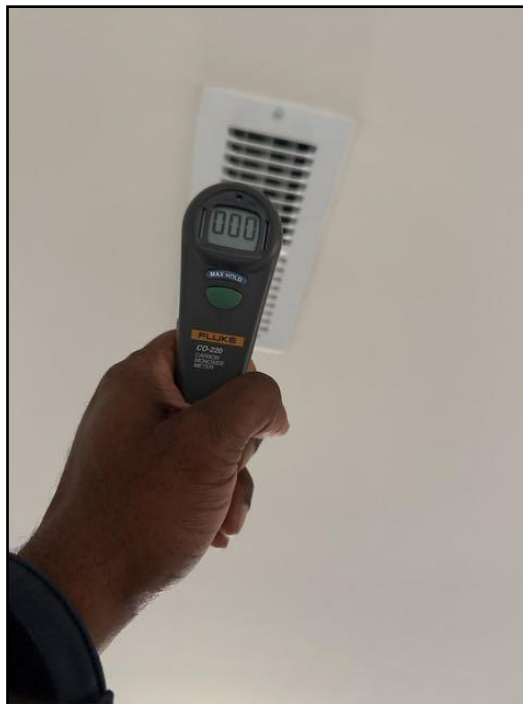
52. 0 parts per million - approximate

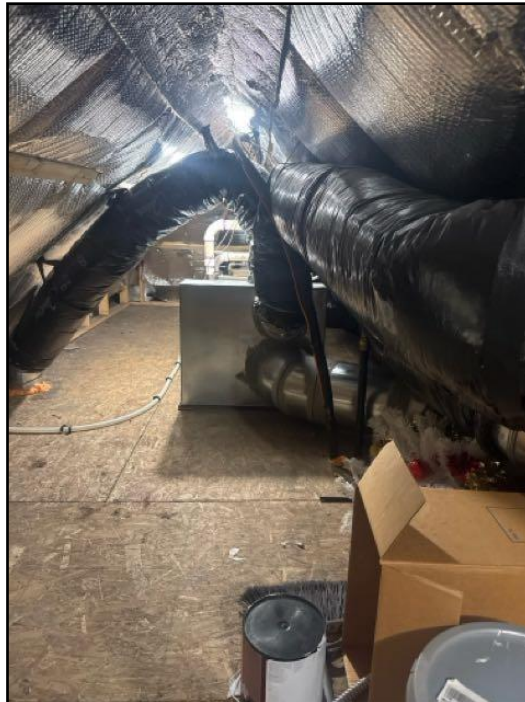
19. Condition: • Attic service receptacle is not present. In the event of routine maintenance or service and repair it is necessary for the technician to have the service receptacle. I recommend installing this receptacle and making the necessary repairs

55. Attic service receptacle is not present. In...

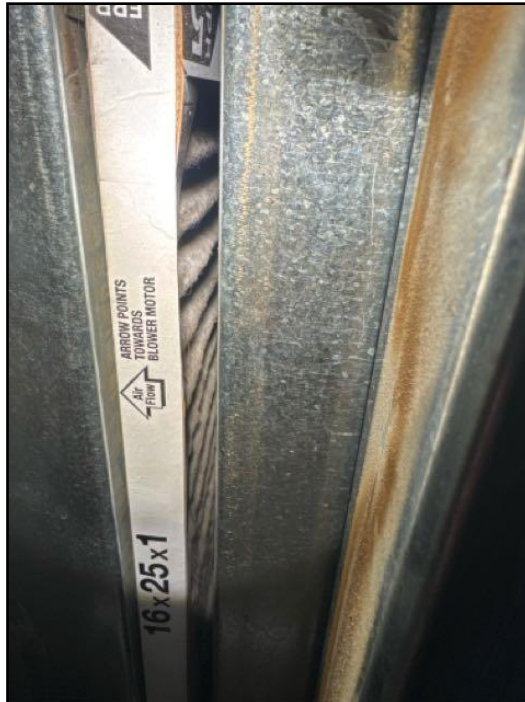
20. Condition: • [Dirty](#)

Filters clean the air headed into the furnace and the heated air sent back into the structure. A dirty, clogged filter limits the airflow, eventually causing heat and pressure to build up in the furnace. Newer, more efficient systems are sensitive to the problem and will often shut down before a dirty filter causes more trouble. For other units, the furnace will continue to run but with less heat output and reduced efficiency

56. Dirty

Task: Change filter

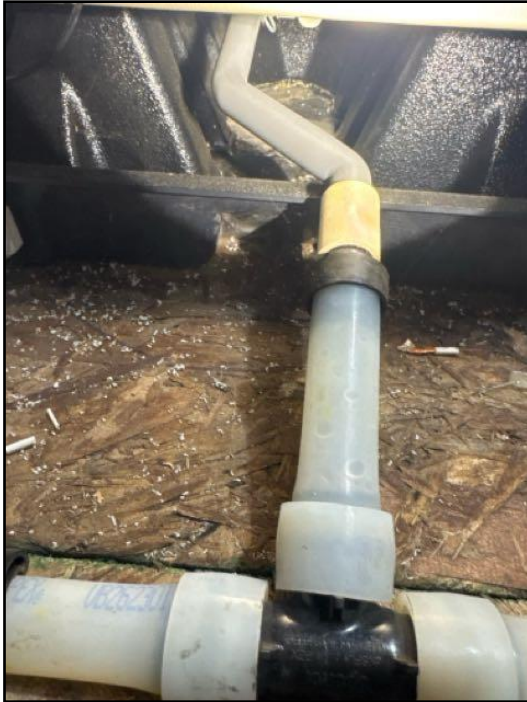
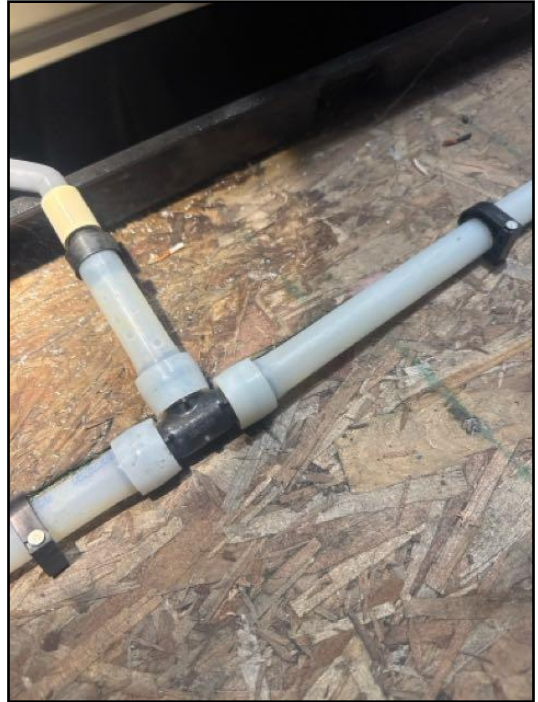
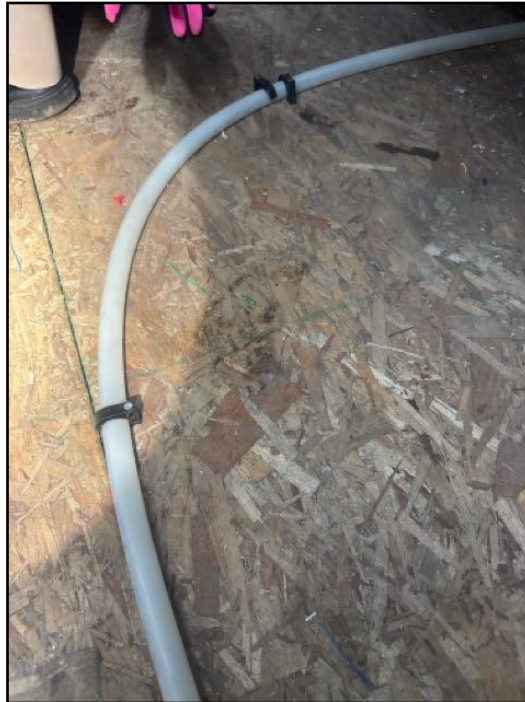
23. Condition: • The high-efficiency furnace in the attic has a blocked condensation drain. The drain line is currently 3/4-inch PEX piping, which is not the manufacturer-recommended material for this application. Condensation lines are typically CPVC with proper diameter and an air gap to allow water to drain safely. The current setup may restrict proper drainage and could be obstructed, especially given the attic environment and potential debris. I recommend having a qualified HVAC contractor replace the drain line with the proper material and ensure it is clear and functioning as intended.

Task: Repair

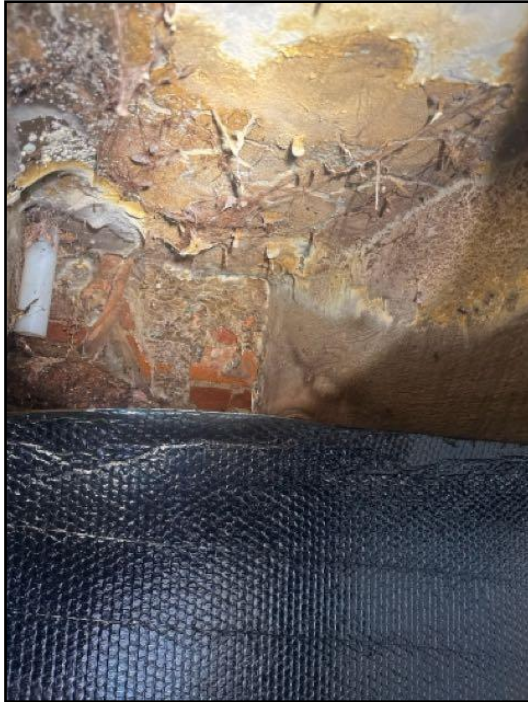
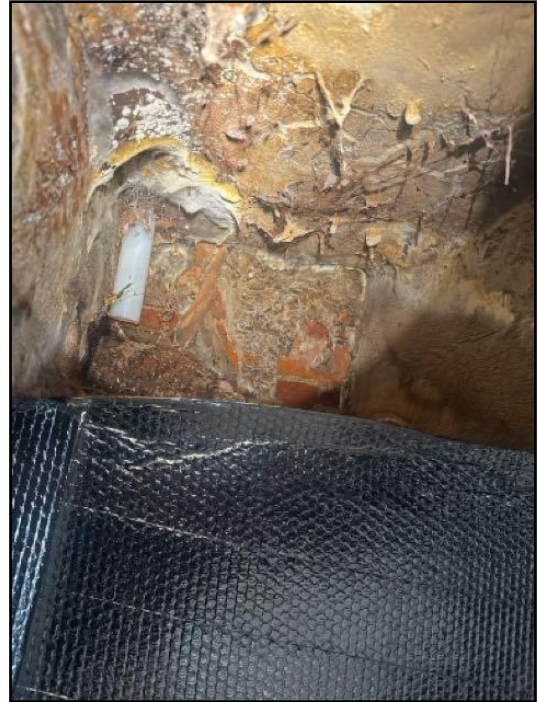
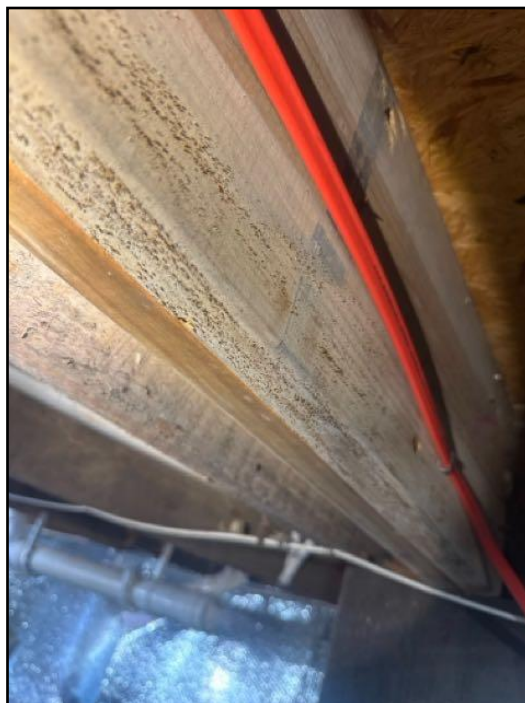
79. This is what appears to be microbial growth...

80. This is what appears to be microbial growth...

81. This is what appears to be microbial growth...

Task: Remediate

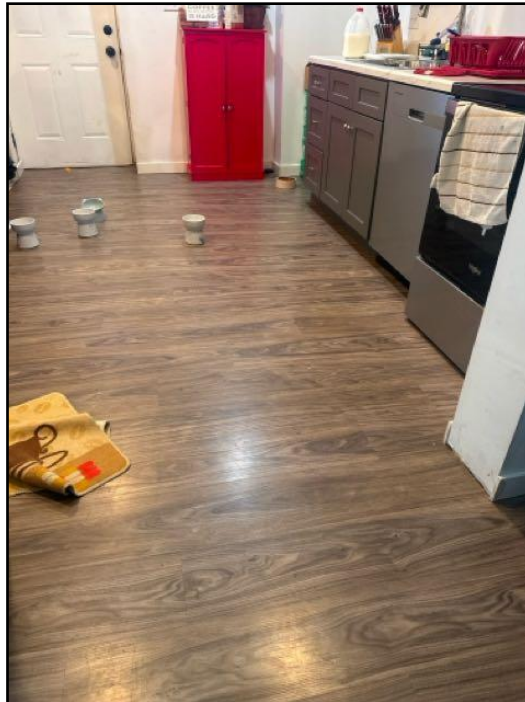
85. Wavy floors are common in old homes. Over...

Task: Recommend improvement

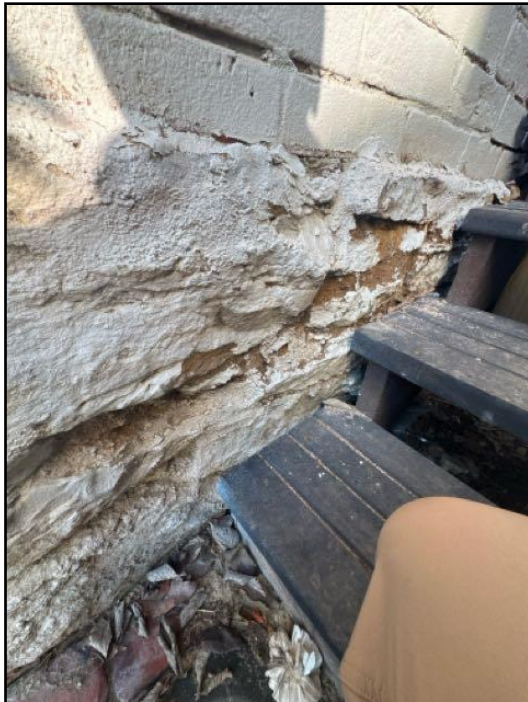
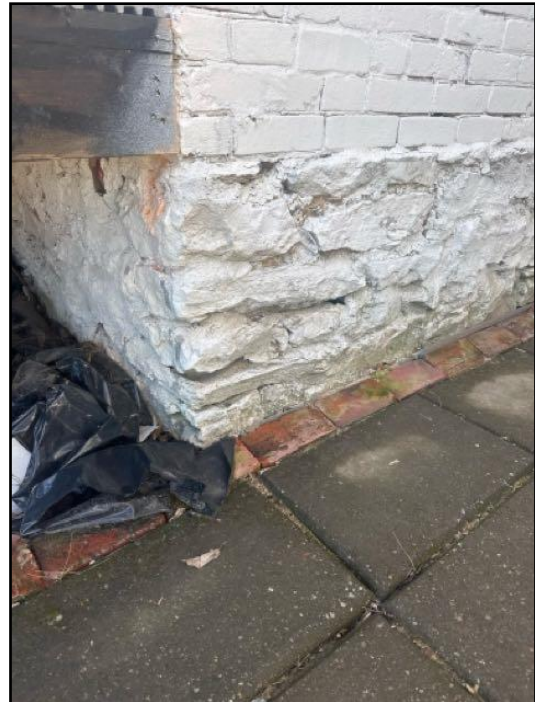
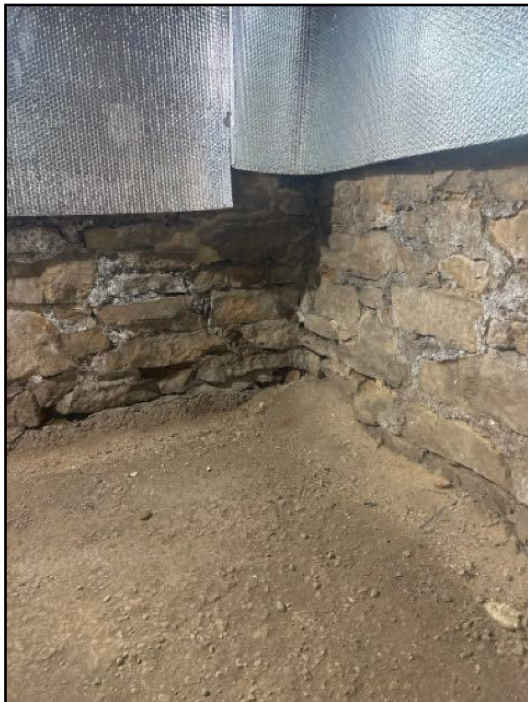
91. You need to be aware basements below grade...

92. You need to be aware basements below grade...

93. You need to be aware basements below grade...

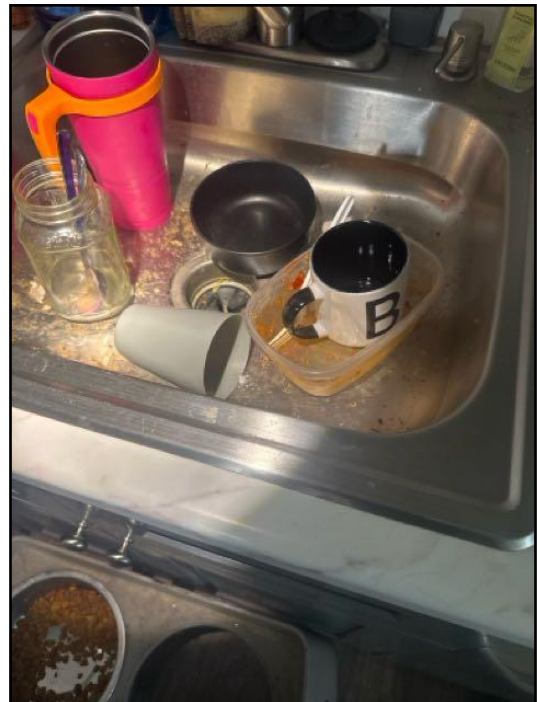
97.

APPLIANCES \ Waste disposal

36. Condition: • Inoperative

The appliance is not functioning as intended, during the home inspection. I recommend discussing with the current owner the manufacture specifications and operation of the appliance.
